SERVICE INFORMATION

PROBLEM: Neutral Positioning Bolt Boss Too Short

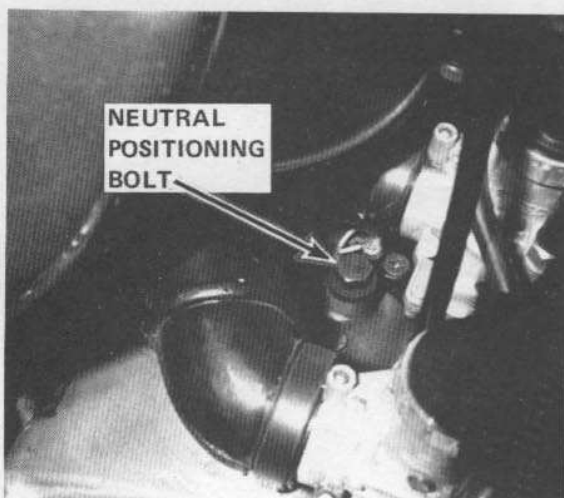
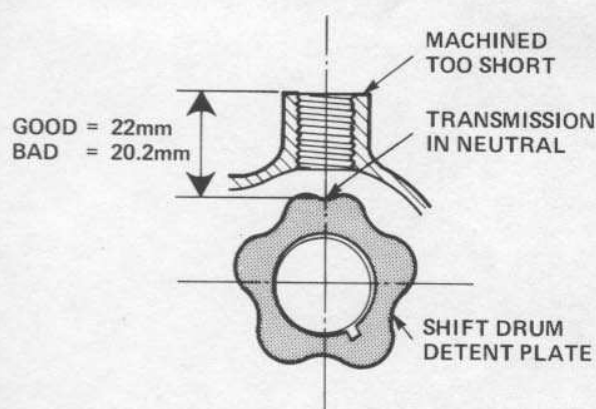
The 1976 KH500 has a neutral positioning bolt on the upper crankcase. On some early KH500's, the positioning bolt boss was machined too short. Installation of the positioning bolt and pin in a short boss may interfere with normal gear changing.

FACTORY ACTION: Installed Extra Gasket and Washer

All affected units have an added gasket and washer under the neutral positioning bolt.
