obsolete
PROBLEM:

CORRECTION:

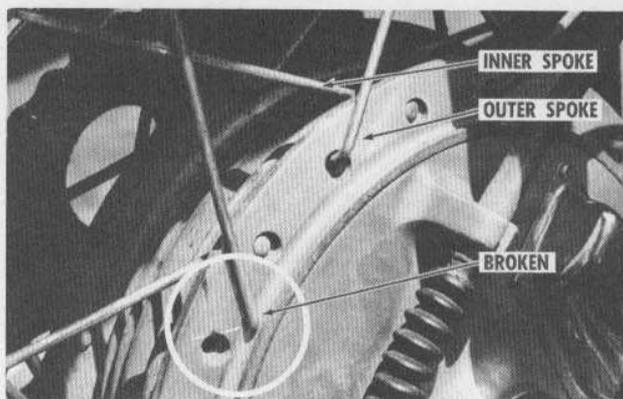
EARLY H1 STRAIGHT-TYPE SPOKES

Rear wheel spoke breakage can occur on 1969-71 H1's, when rider operation is very demanding. Hard acceleration and braking impose great tensile (pulling) stresses on the rear wheel spokes. Breakage happens most often when the pavement is alternately wet and dry, such as accelerating through an underpass, where the tire may spin on wet pavement or gravel and then "grab" when passing onto dry pavement. Generally, the spoke breaks at the bend near the hub end.
