PROBLEM:

On early H1 and H2 models, there have been problems of gear engagement resulting from excessive play in the stationary gears on both the drive and output shafts.

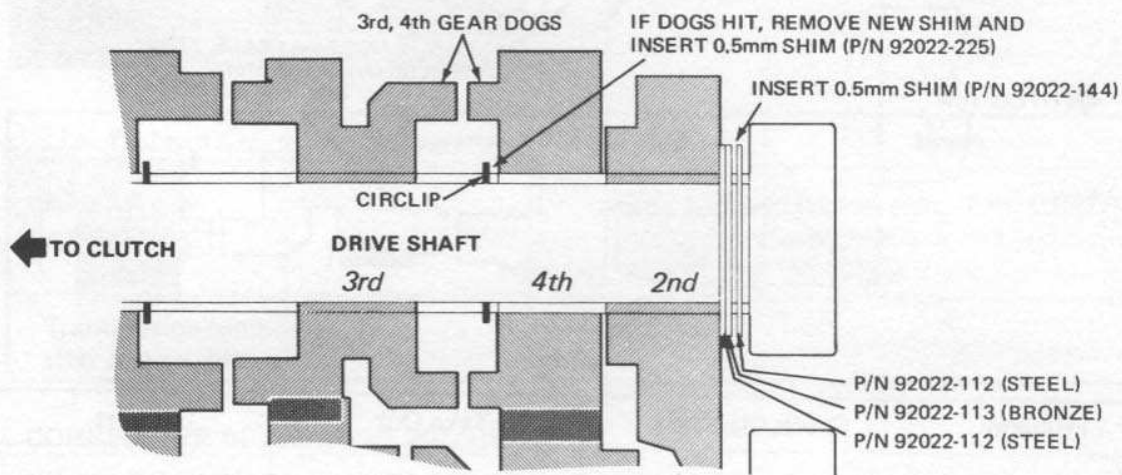
A. CORRECTIVE ACTION FOR 4TH GEAR:

4th Gear Problem	Clearance	Take Out	Insert
Jumps out of 4th gear.			0.5mm shim (92022-144) along with shims already present between second gear and end bearing on drive shaft.
4th gear dogs hit 3rd gear dogs in neutral after adding shim.		Remove new 0.5mm shim between 2nd gear and end bearing on drive shaft.	Add 0.5mm shim (P/N 92022-225) between 4th gear and circlip on drive shaft.

1. Insert an 0.5mm shim (P/N 92022-144) between second gear and the bearing on the drive shaft. The shim goes between the bronze and steel washers already present. This moves second and fourth gears over toward the third gear slider, making a more positive engagement of fourth. If the shaft turns hard, take the shim back out.
2. If fourth gear dogs hit third gear dogs after adding the shim, then take it back out and add a 0.5mm shim (P/N 92022-225) between 4th gear and the circlip. This keeps the sloppiness out of the gear without forcing the dogs together.

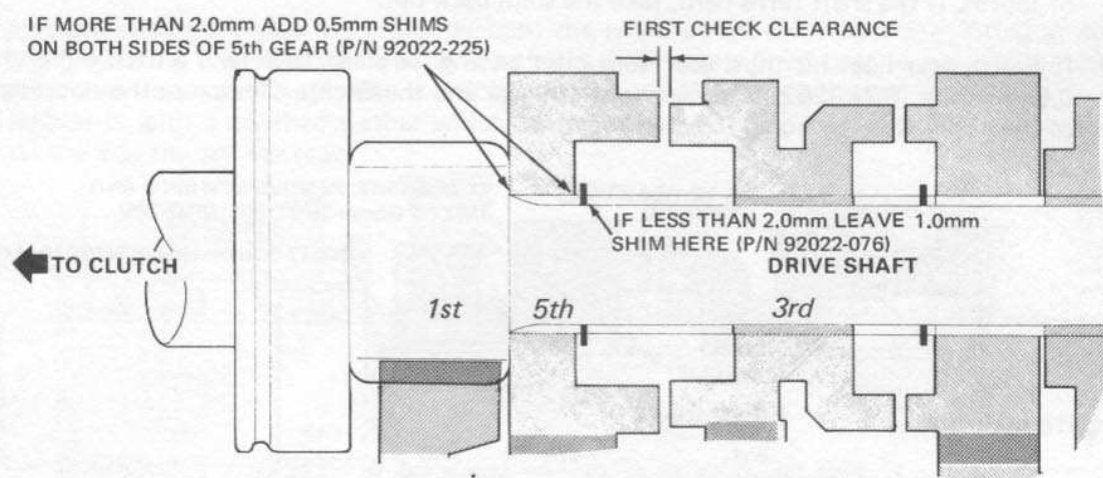
B. CORRECTIVE ACTION FOR 5TH GEAR:

Problem	Check Clearance	Take Out	Insert
Jumping out of 5th gear.	Ck clearance between 5th and 3rd gear dogs on drive shaft.	If clearance is greater than 2.0mm take out 1.0mm shim between 5th and circlip.	Insert 0.5mm shim (P/N 92022-225) on either side of 5th gear on the drive shaft.
		If less than 2.0mm leave shim where it is.

- To eliminate jumping out of fifth gear, measure the clearance between fifth and third gear dogs on the drive shaft. If the clearance is over 2.0mm, remove the factory installed 1.0mm shim (P/N 92022-076) between fifth gear and the circlip, and add a 0.5mm (92022-225) shim on either side of fifth gear. This moves fifth gear 0.5mm closer to the slider gear, assuring a more positive engagement. If the clearance is less than 2.0mm between dogs on the two gears, then leave the 1.0mm shim where it is.

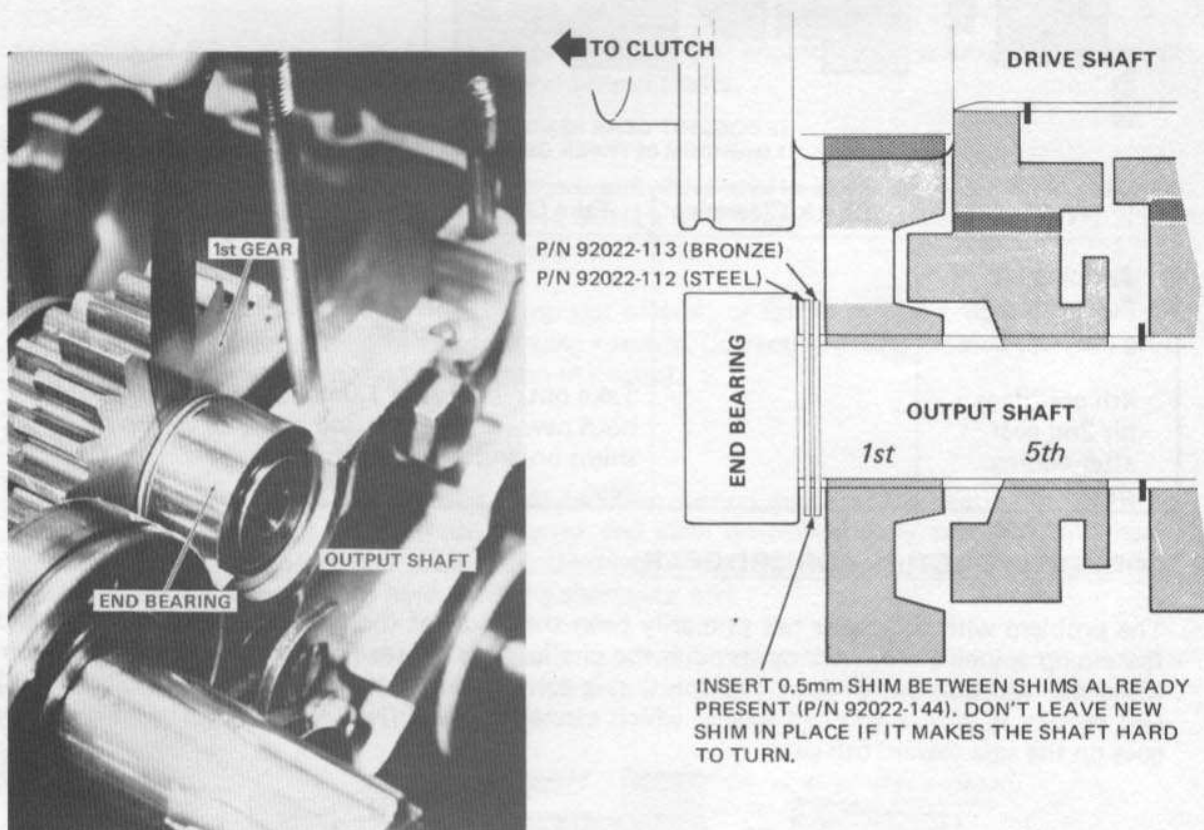
C. CORRECTIVE ACTION FOR 1ST GEAR:

Problem	Check Clearance	Take Out	Insert
Poor 1st gear engagement.			Add 0.5mm shim (P/N 92022-144) between first gear and end bearing on the output shaft.
Transmission binds after adding shim.		Take out new shims.

To correct poor engagement of 1st gear, insert an 0.5mm shim (P/N 92022-144) between first gear and the end bearing on the output shaft. This is in addition to the shims already present (P/N 92022-112, -113). This moves 1st gear slightly closer to the slider gear and eliminates play which may have contributed to jumping out of gear. If adding this shim makes the output shaft hard to turn, then take it back out.

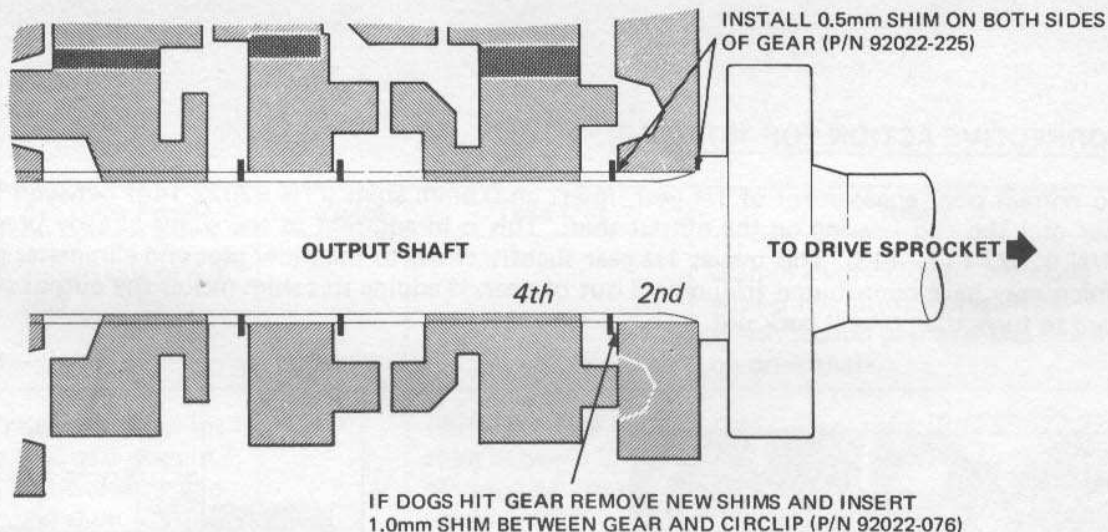
D. CORRECTIVE ACTION FOR 2ND GEAR:

Problem	Check Clearance	Take Out	Insert
Jumping out of 2nd gear.			Add 0.5mm shim (92022-225) on both sides of 2nd gear on the output shaft.
4th gear dogs hit 2nd gear after adding shims.		Take out both new shims on 2nd gear.	Add 1.0mm shim (92022-076) between 2nd gear and circlip on output shaft.

To eliminate play at second gear on the output shaft, install a 0.5mm washer (P/N 92022-225) on both sides of the gear. This moves the gear slightly closer to the fourth gear slider as well as reducing play. If the dogs on fourth gear hit second gear after the shims are added, remove both new shims and add a 1.0mm shim (92022-076) between second gear and the circlip. This will keep the dogs from hitting, while eliminating play at second gear.

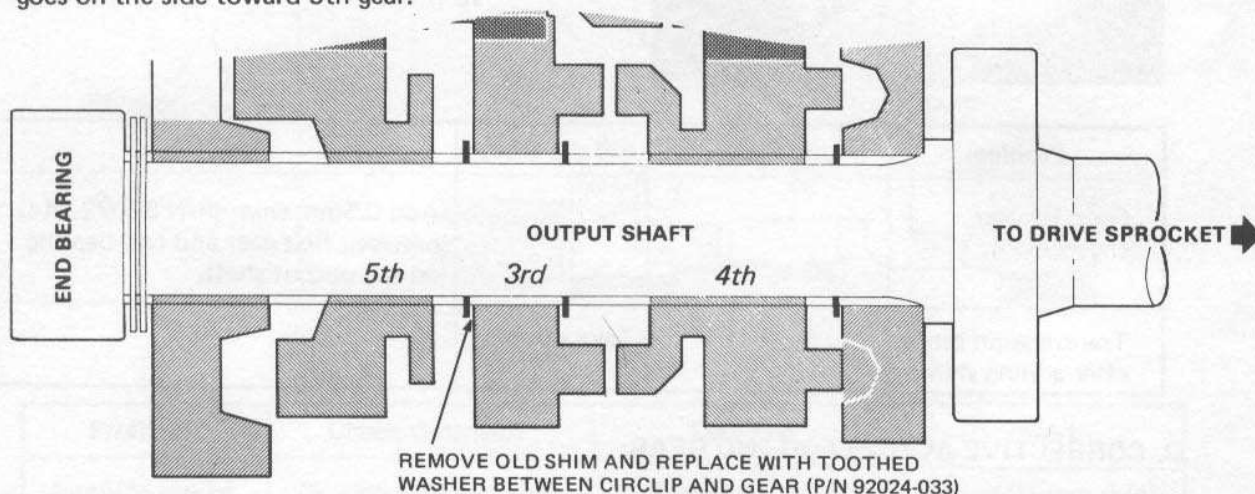
E. CORRECTIVE ACTION FOR 3RD GEAR:

Problem	Take Out	Insert
Jumps out of 3rd gear.	Remove 1.0mm shim between 3rd gear and circlip on output shaft.	Insert 1.0mm toothed thrust washer (P/N 92024-033) between 3rd gear and circlip (5th gear side).

The problem with third gear has primarily been the result of the shim between 3rd gear and the circlip spinning and wearing through the circlip. This causes third gear to move away from the slider and hop out of gear. The solution is to remove the standard shim (P/N 92022-076) and replace it with a toothed washer which cannot rotate (P/N 92024-033). The new washer goes on the side toward 5th gear.
