## PROBLEM:

In the transmissions of H1 models there is a possibility for unusually fast wear on the inside of top gear on the drive shaft. As the gear wears, it begins to wobble on the shaft, eventually causing serious trouble in the transmission.

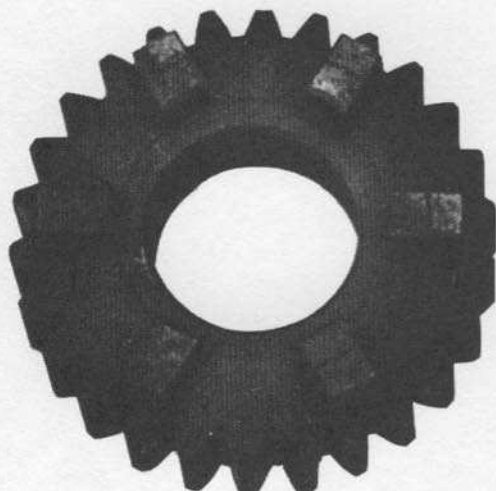
### OLD

Top Gear  
(No Bushing)  
P/N 13136-022

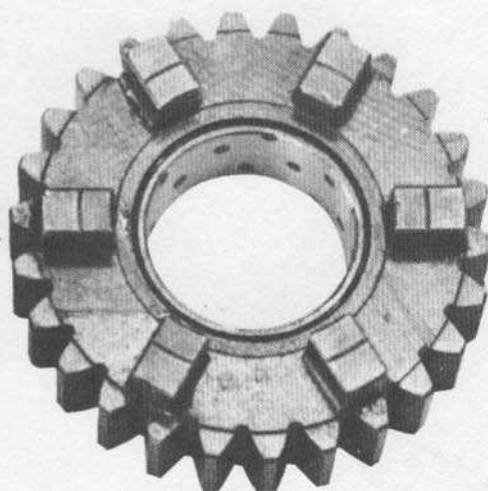
### NEW

Top Gear  
Bronze Bushing  
P/N 13136-041

To eliminate this possibility, top gear on the drive shaft has been changed. The new gear is made with a pressed in bronze bushing for extended life. This change has been applied to all H1's in production from frame number KAF-57161, and to all H2's from beginning of production.
