©Kawasaki Motors Corp 1974 Printed in USA

PROBLEM:

The alternator rotor, being mounted on the end of the crankshaft, turns at the same speed as the engine. At high engine rpm, the centrifugal force on the rotor winding is considerable. Failure of the rotor can result because the winding is stretched and either shorted or snapped by the tremendous force.

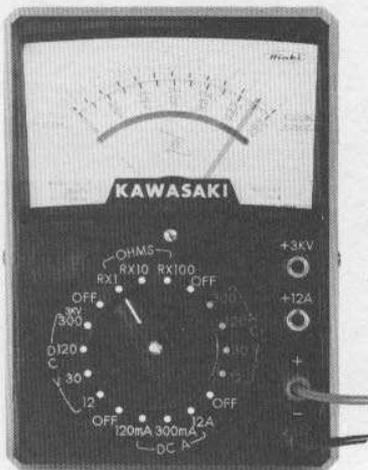
3.5 to 5.5 OHMS

The rotor may be checked by testing the resistance between the inner and outer slip of the rotor with a multimeter set in the RX1 position. Touch one lead to each slip ring as illustrated; the resistance should be between 3.5 and 5.5 ohms. If the resistance is greater than 5.5 ohms, the windings have been snapped (open circuit). If the resistance is less than 3.5 ohms, the windings have shorted (short circuit). Now touch one lead to the core (center) of the rotor and the other to each slip ring in turn. The resistance for both should be infinite. Any other reading indicates that the slip ring is grounded.

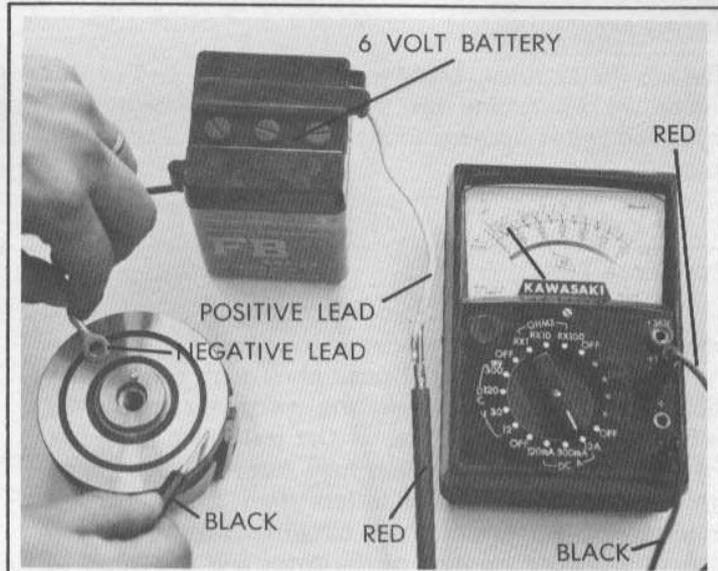
A defect which shows up only under load may be detected as follows. Set the selector switch to the "12 A" position and plug the red lead into the "+12 A" hole. Connect the red lead to the positive lead from a six volt test battery. **CAUTION:** Don't use a 12V battery or you could ruin the rotor windings. Touch the negative lead from the battery to one of the rotor slip rings. Momentarily, tap the black lead from the multimeter on the other slip ring. If the needle swings wildly across the face of the meter the rotor is shorted.

Do not hold the black lead to the slip ring under these conditions or the multimeter will be damaged. If the needle rises to 1.1 to 1.7 amps (read the 0 to 120 scale as 0 to 12.0 amps) the rotor is good. A lower reading indicates an open circuit.

With any of these types of failure, the rotor must be replaced.

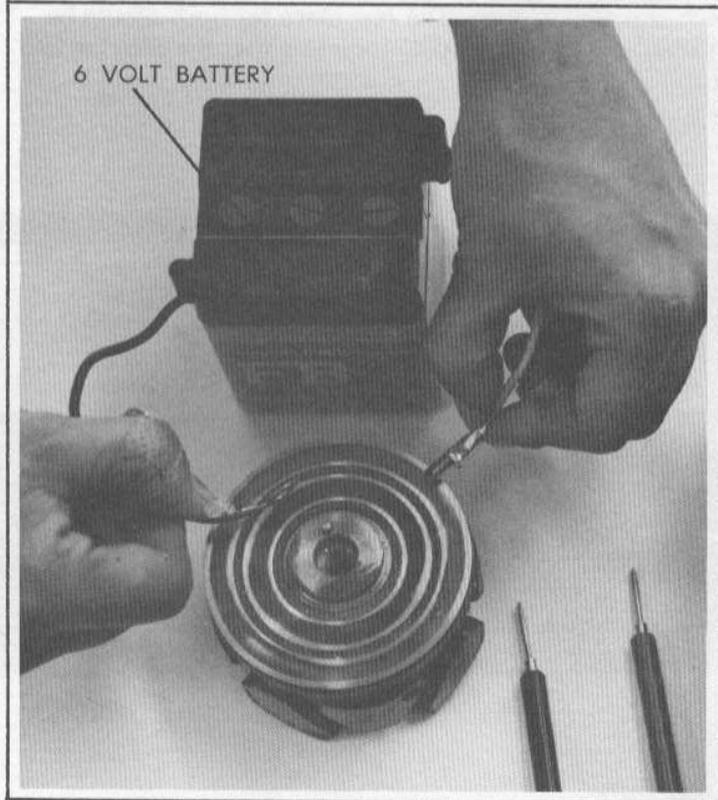
Connect the 6 volt battery to the rotor as shown with one lead to each slip ring. Remove the battery after thirty seconds and measure the resistance as before. If the reading is out of the acceptable range after this 6 volt load, the rotor is defective.

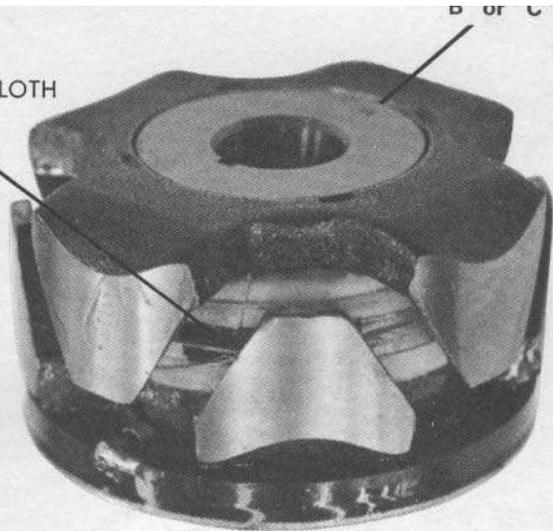
SQUARE HOLE IN CLOTH

There have been two changes in the rotor (part no. unchanged) to counter-measure this tendency toward high rpm failure. These rotors may be identified by square holes in the insulating cloth on the windings. The "B" type rotor is used in production from engine number KAE-43491 to KAE-69531. The latest modification, marked "C", changes the rubber based resin to plastic based. This rotor is used on engines KAE-69532 and up.
