The following corrections should be made to the SM-2 Revised (July 1, 1971)

NOTE: The SM-2 Revised does not contain any service information on the H1B. Use the new H Series Shop Manual for the H1B.

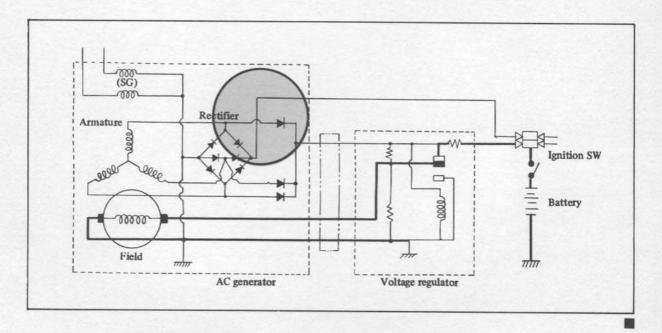
F. Page 46, 47. These two pages are correct for the S2, but not for the H1. See the corrections for pages 44 and 45 of the new H Series Shop Manual for the H1.

G. Page 97. Diagram #407 should be corrected to match the diagram below:
