©Kawasaki Motors Corp 1974 Printed in USA

H1/H2 transmission problems have often included poor third gear engagement. This may be caused by two possible problems including the play of the fixed gears on the shafts and the lack of positive action in the third gear shift fork.

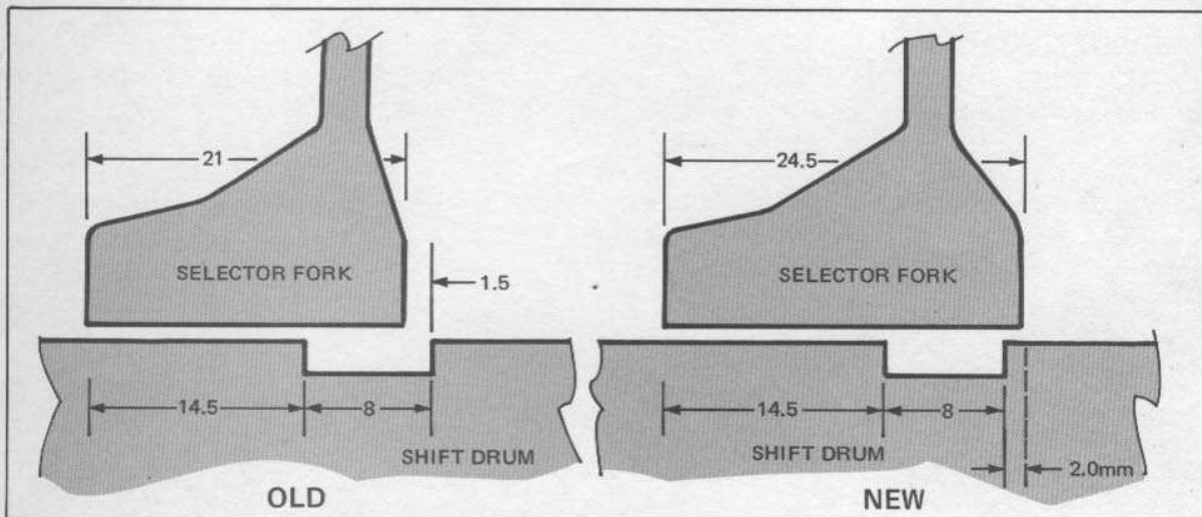
The second problem has been countermeasured by widening the base of the shift fork to keep the fork more rigid on the shift drum. This wider fork is supported on both sides of the groove on the shift drum.

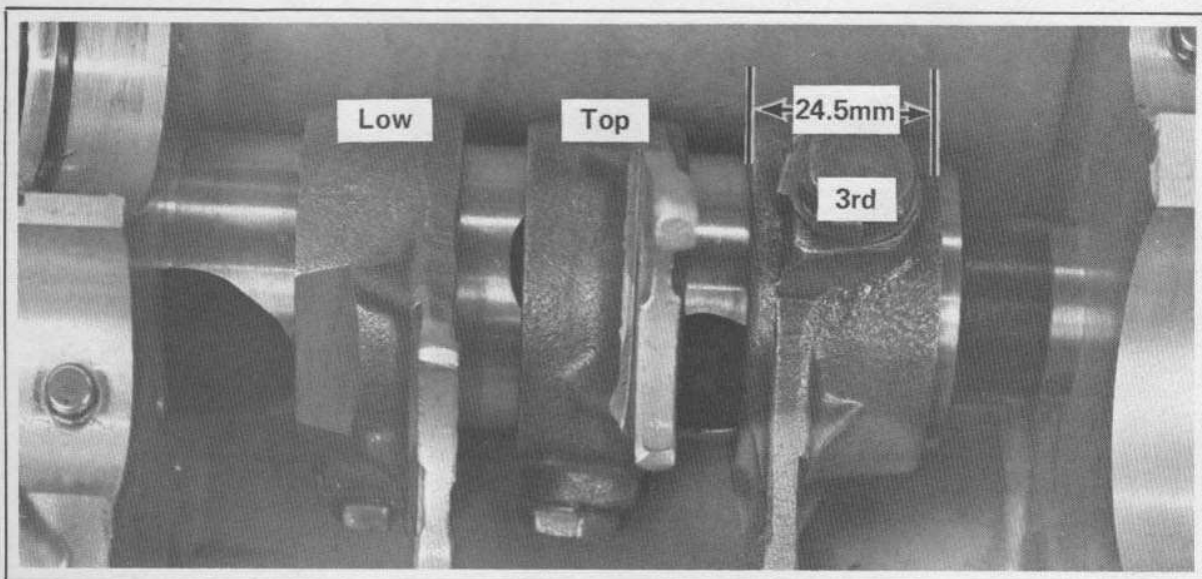
The new fork is easily recognized by its wide base.
