©Kawasaki Motors Corp 1974 Printed in USA

PROBLEMS:

H1/H2 transmission problems have often included poor third gear engagement. This may be caused by two possible problems including the play of the fixed gears on the shafts and the lack of positive action in the third gear shift fork.

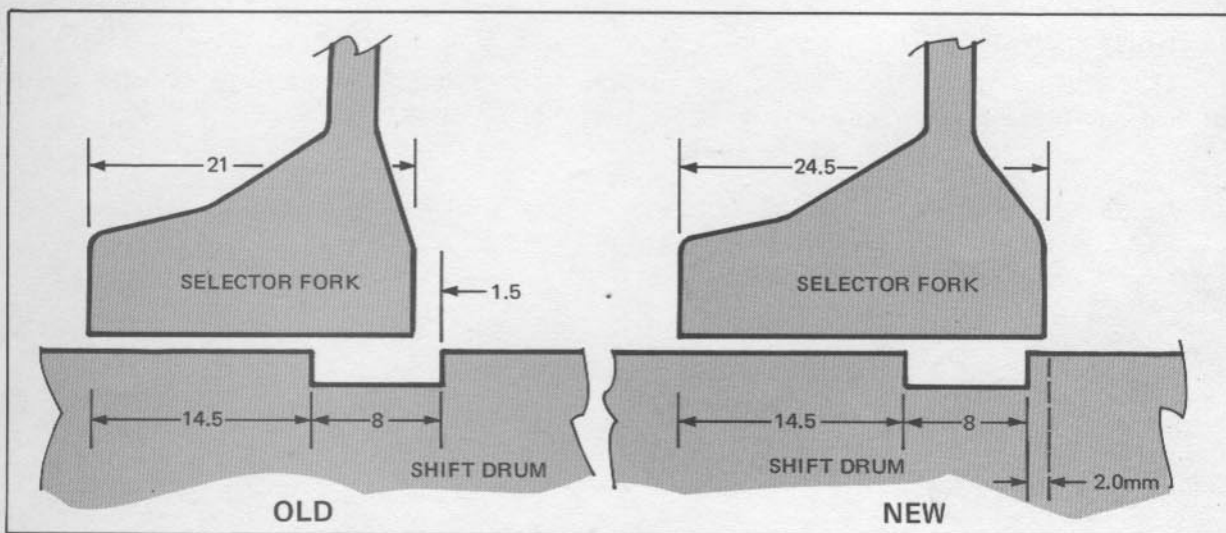
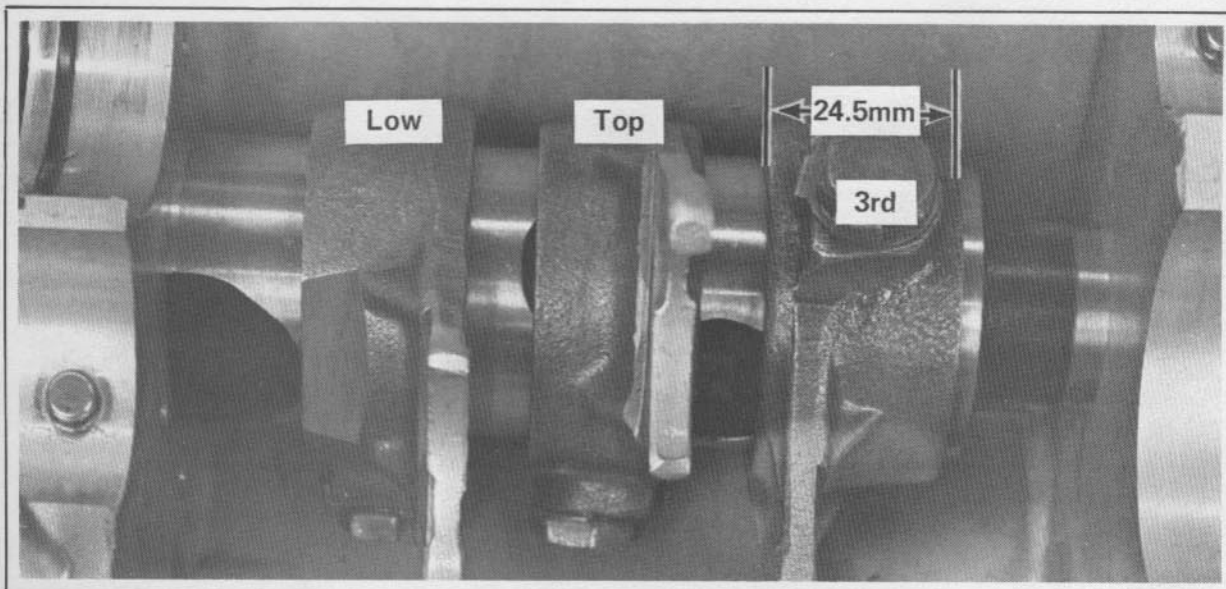
The second problem has been countermeasured by widening the base of the shift fork to keep the fork more rigid on the shift drum. This wider fork is supported on both sides of the groove on the shift drum.

The new fork is easily recognized by its wide base.

Adjustment of the play in the transmission has been improved in H1 production since engine number KAE-59017, and H2's from beginning of production. See Bulletin Ser 73 H-21 for adjustment instructions.

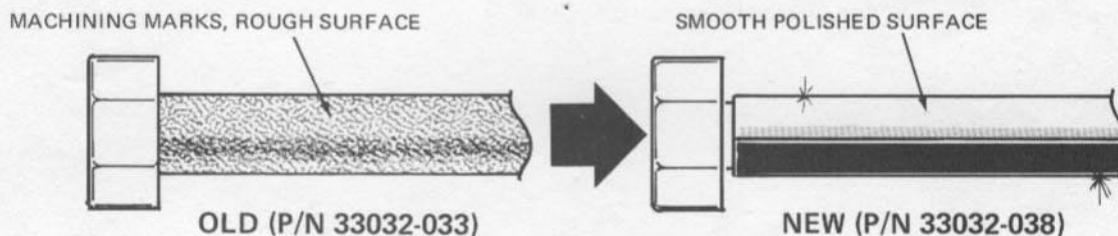
The H2A pivot shaft has a smooth polished surface as compared to the H2 pivot shaft which has a semi-rough machined surface.

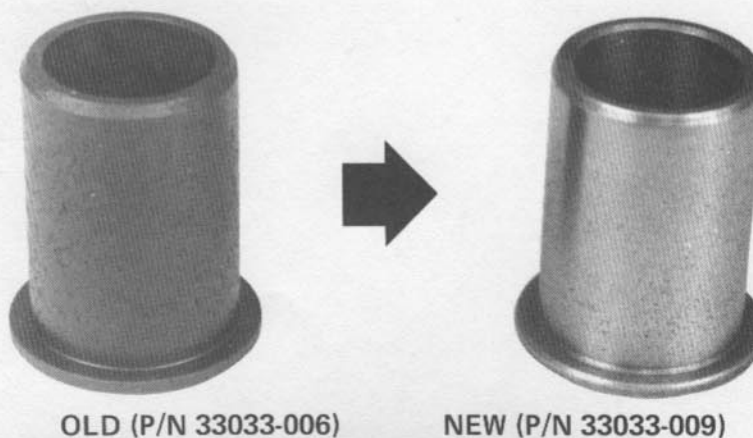
The H2 uses phenolic bushings made of a cotton or asbestos filler bonded with a phenolic resin. The H2A uses sintered iron bushings for better resistance to wear and fracture. The sintering process produces a spongelike structure in the metal making it capable of absorbing 20 percent of the total volume with lubricant. This type of bearing is ideal in areas where lubrication is infrequent.

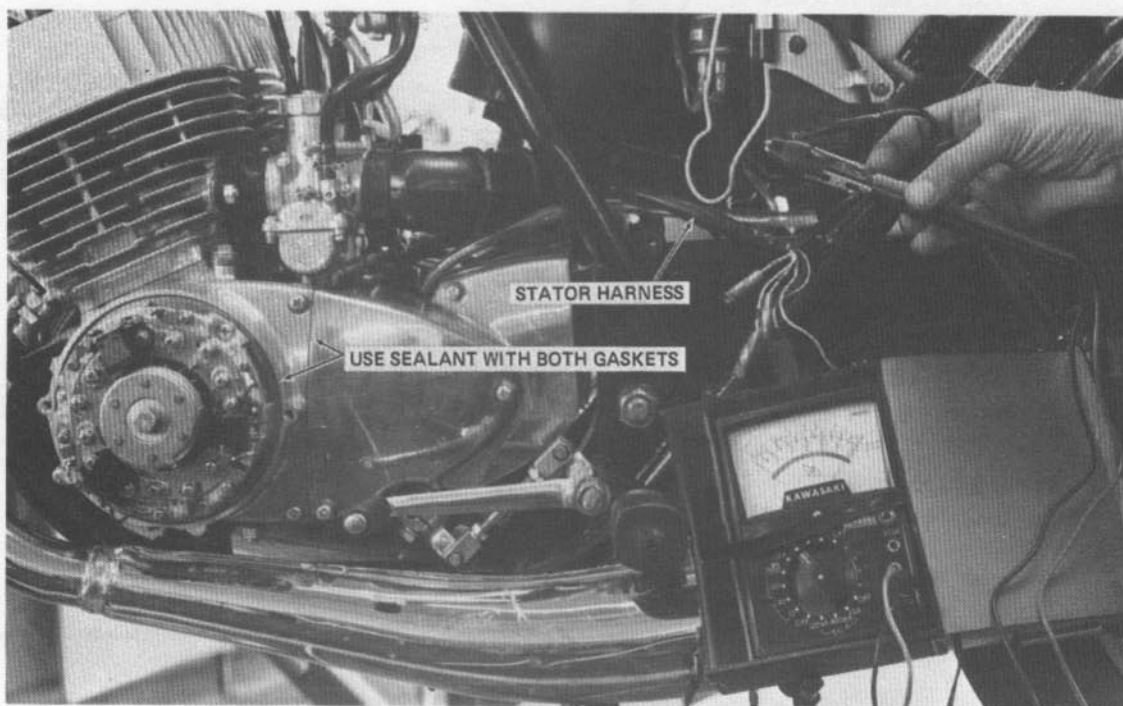
There are several different problems which can result from a stator assembly failure on the H1D or H2. The purpose of this bulletin is to supply some of the possible effects of a defective stator and to offer a comprehensive guide for checking the stator assembly.

1. The insulation of the coils can be too thin in areas causing an internal short or a short to ground.
2. Engine vibration can lead to an open or short circuit.
3. Engine heat contributes to stator assembly failure.
4. Water corrosion on the AC generator due partially to condensation but primarily resulting from leakage is a large contributor to stator assembly failure.

If the stator is suspected to be defective, remove the L.H. inspection cover and visually check the stator assembly for broken wires, loose coils or other signs of damage. If nothing is found, remove the L.H. side cover and disconnect the stator wires.

Then by using a Kawasaki ohm meter (P/N 56019-037) follow the circuit tests below. **NOTE:** It is advisable to make these checks with the stator installed on the engine, because some problems such as the stator coils touching the engine crankcase may otherwise go undetected.

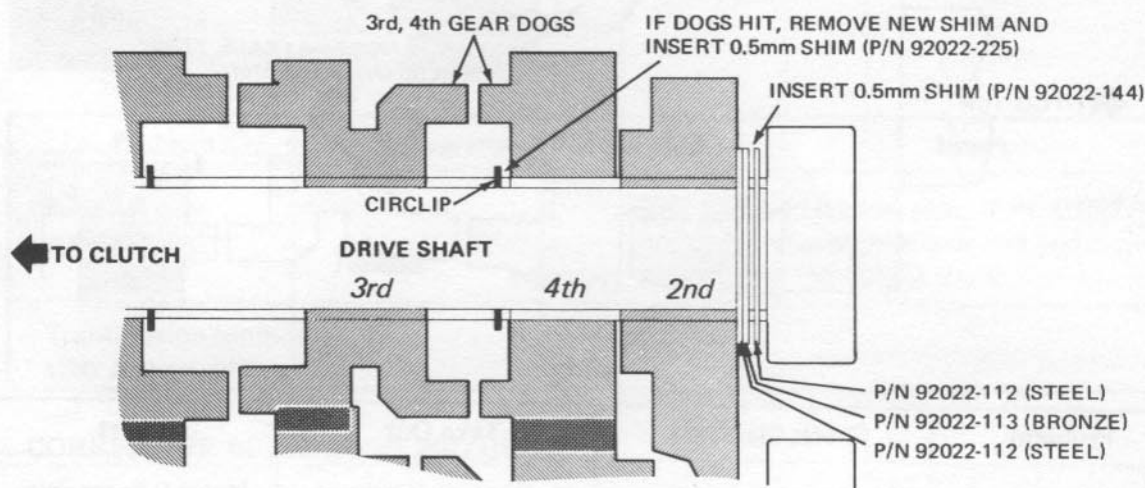
For those H1 and H2 motorcycles which jump out of gear, or fail to engage properly, corrective adjustment may be accomplished in the following manner. Corrective action is listed for each gear. All clearances are checked with the transmission in neutral.

1. Insert an 0.5mm shim (P/N 92022-144) between second gear and the bearing on the drive shaft. The shim goes between the bronze and steel washers already present. This moves second and fourth gears over toward the third gear slider, making a more positive engagement of fourth. If the shaft turns hard, take the shim back out.
2. If fourth gear dogs hit third gear dogs after adding the shim, then take it back out and add a 0.5mm shim (P/N 92022-225) between 4th gear and the circlip. This keeps the sloppiness out of the gear without forcing the dogs together.

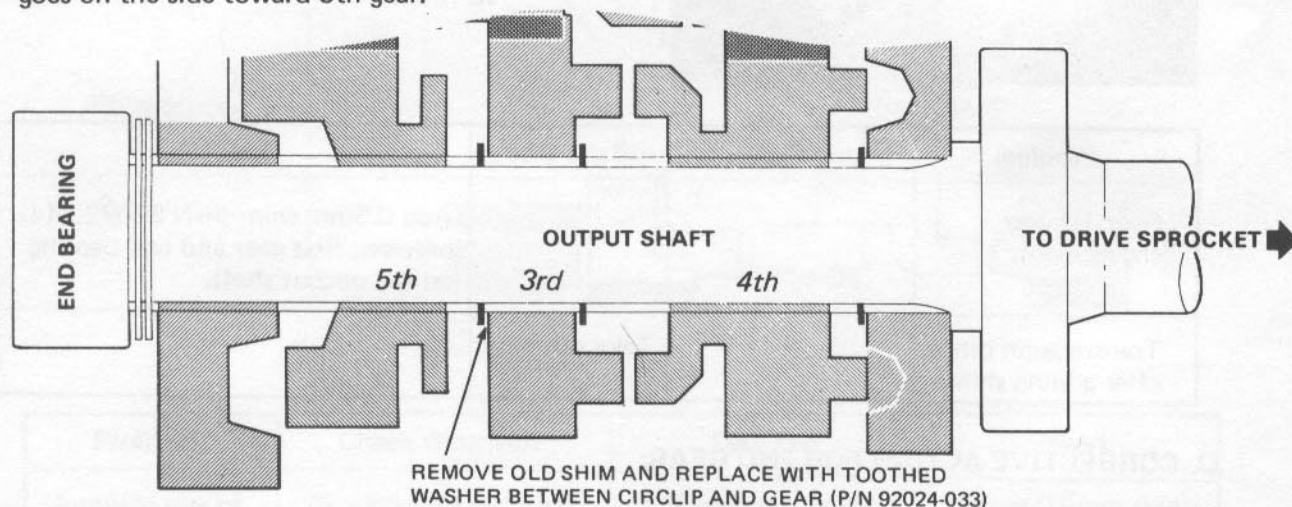
The problem with third gear has primarily been the result of the shim between 3rd gear and the circlip spinning and wearing through the circlip. This causes third gear to move away from the slider and hop out of gear. The solution is to remove the standard shim (P/N 92022-076) and replace it with a toothed washer which cannot rotate (P/N 92024-033). The new washer goes on the side toward 5th gear.

Problem		Take Out	Insert
Jumps out of 3rd gear.		Remove 1.0mm shim between 3rd gear and circlip on output shaft.	Insert 1.0mm toothed thrust washer (P/N 92024-033) between 3rd gear and circlip (5th gear side).

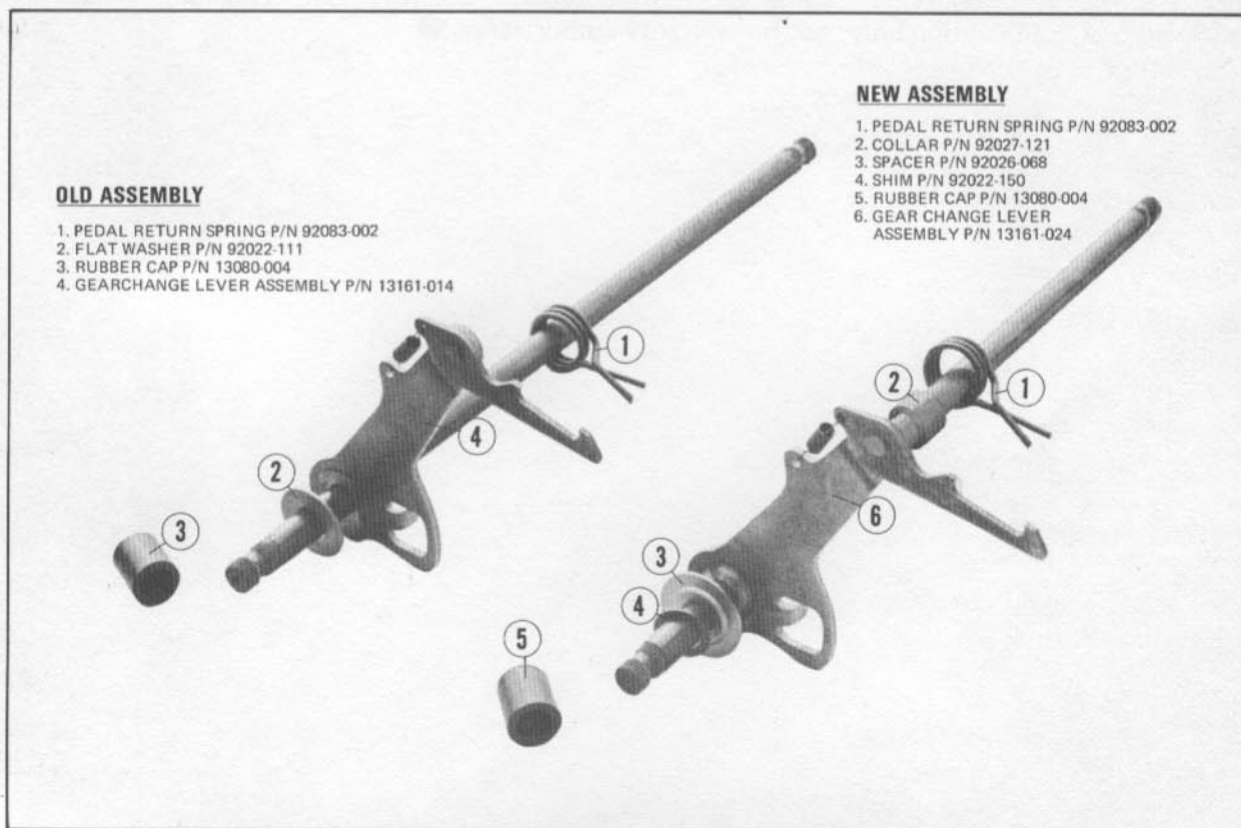
On the early H1 models, the gear change lever assembly consisted of a toothed lever staked to a rod. This construction sometimes loosened up, causing sloppiness in shift lever movement. This contributed to missed shifts, and sometimes led to transmission damage.

The correct assembly of the new gear change lever assembly is pictured on the right below. The outside shim (P/N 92022-150) does not yet appear in any parts books but it is included in the position shown on current production machines of both H1 and H2. The new assembly is used on all H1's after Engine No. KAE 43902 and on all H2's, and is interchangeable with older parts.

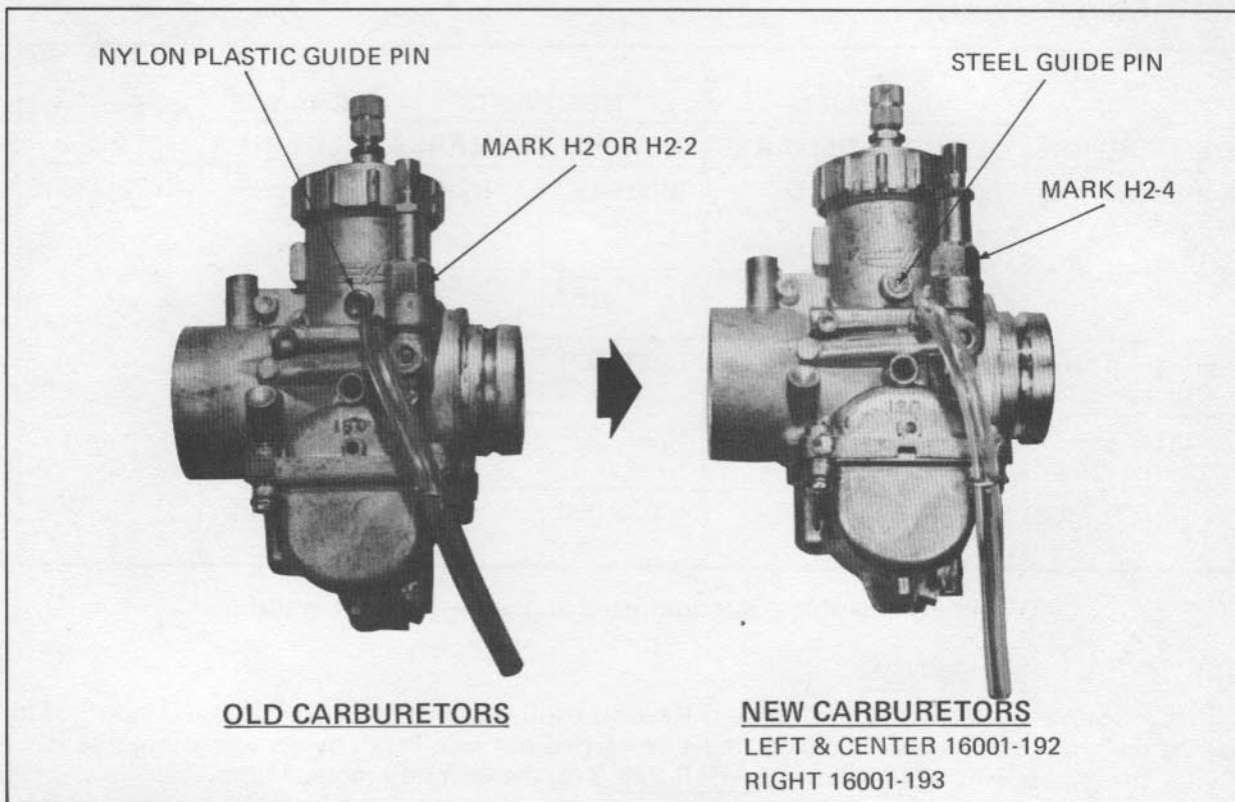
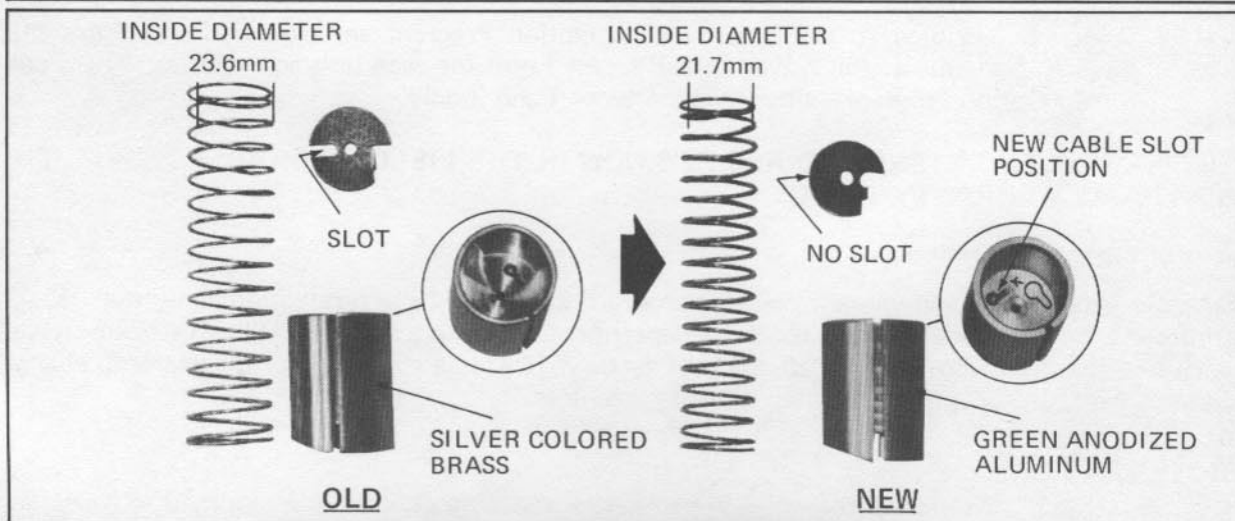
By monitoring warranty records, it has been determined that carburetor jet needle breakage is a recurring problem on many H2's. This failure results from the combination of throttle valve bore wear and engine vibration. In some cases, the broken jet needle has become lodged in the engine, causing severe damage.

To remedy the problem of jet needle breakage and reduce the possibility of engine damage, the three original carburetors must be replaced with new-type carburetors designed specifically to eliminate this problem. The new carburetors incorporate a redesigned light weight throttle valve slide, a heavier return spring, a modified spring seat, and a steel throttle valve guide pin. All other component parts remained unchanged from the "H2-2" type carburetor.

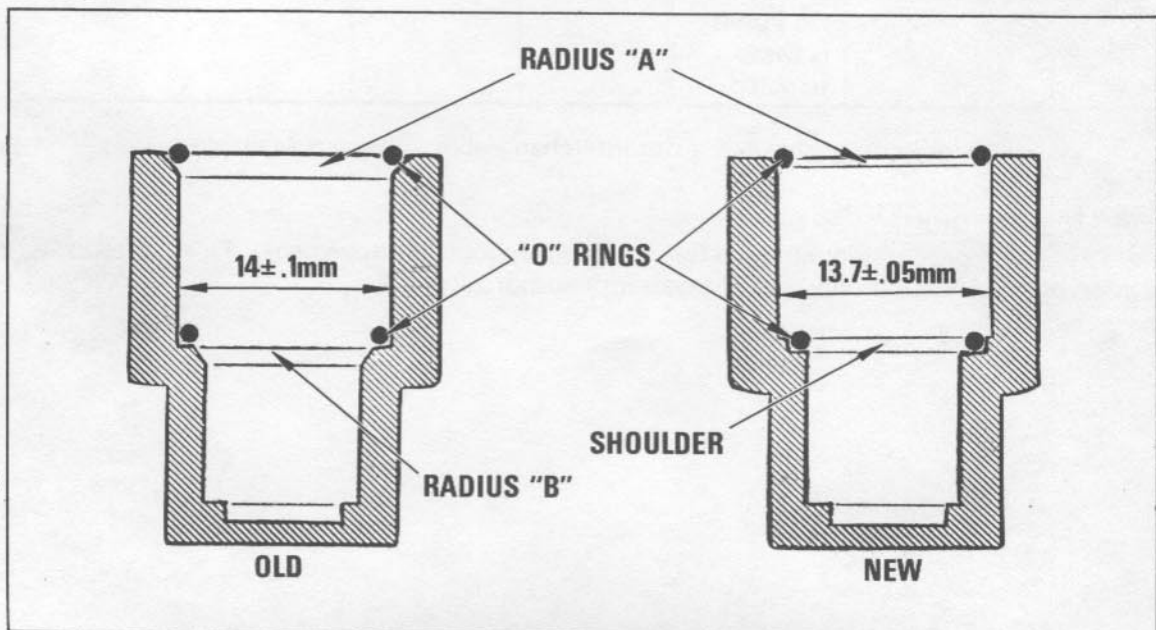
CAUSE:

This problem has been traced to faulty O-ring seating in the oil pump end cover. After installation, the two O-rings inside the cover shrink approximately .1 to .2mm in diameter. This shrinkage allows oil to seep around the seals and into the end cover chamber. From this point, the excess oil is pumped to the right cylinder which is serviced by the end cover orifice, resulting in smoking and premature sparkplug failure.

It should be noted that other symptoms may indicate oil pump malfunction, such as right hand piston seizure. This may be caused by oil being forced back into the main pump body through defective O-rings. As a result, the right cylinder is starved for oil, and this situation will eventually lead to seizing.

- A. Radius "A" has been decreased in depth to give the O-rings less "squish" space, making a tighter seal.
- B. Radius "B" has been eliminated altogether, improving the seal at this point.
- C. The internal diameter of the chamber has been decreased from $14 \pm .1\text{mm}$ to $13.7 \pm .05\text{mm}$ to compensate for O-ring shrinkage.
- D. A slight shoulder has been added to the base of the new chamber to further compress the O-ring.

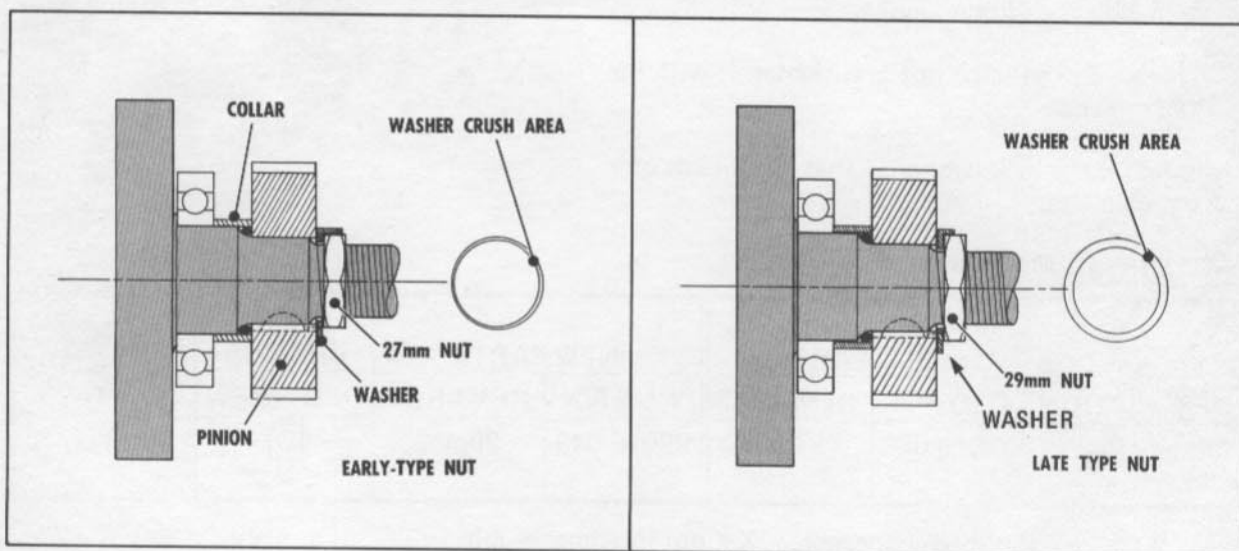
In the H2, a knocking noise may develop in the right engine cover which sounds like a worn, loose clutch. The knock is caused by play between the crankshaft, woodruff key, and primary pinion. If the knocking is allowed to continue the woodruff key may be damaged.

Surprisingly, the primary pinion nut does not loosen (turn) on the crankshaft. Instead, the lockwasher is crushed, relieving the pinion of nut tension. Then the gear is held from twisting only by the woodruff key. As the drawing below shows, the "crush" area on the lockwasher, which is determined by the I.D. of the pinion gear and the O.D. of the pinion nut, is very small.

The knocking results from the pinion keyway hitting the woodruff key as the pinion twists on the crankshaft.

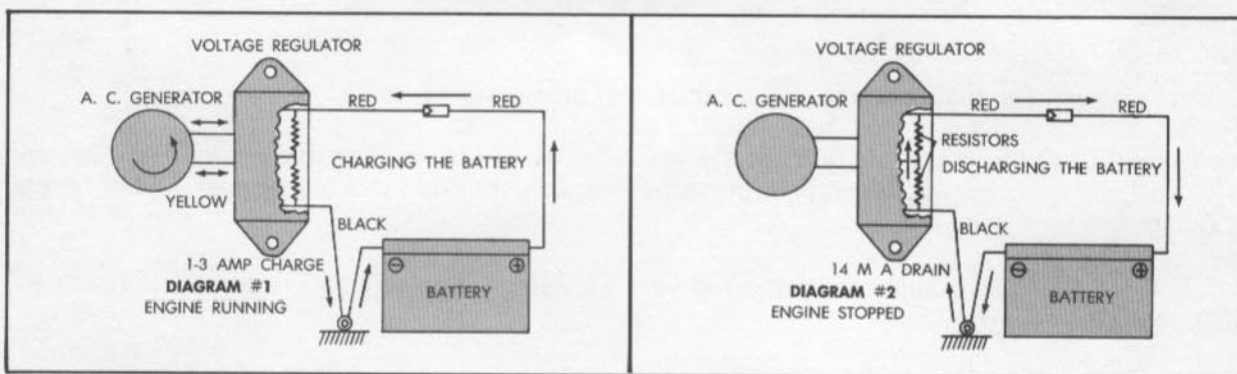
The H2 voltage regulator is connected to the battery by a red wire. This red wire carries the battery charging current when the engine is running. Because of two small resistors in the regulator circuitry, there is a slight current drain on the battery when the engine stops. In a fully charged state, it would take 2-3 weeks of inactivity for the battery to reach a serious discharge condition, because the current draw is so small (12-16 MA).

A supplemental rectifier has been developed to stop reverse current leakage, and yet allow generator current to charge the battery.

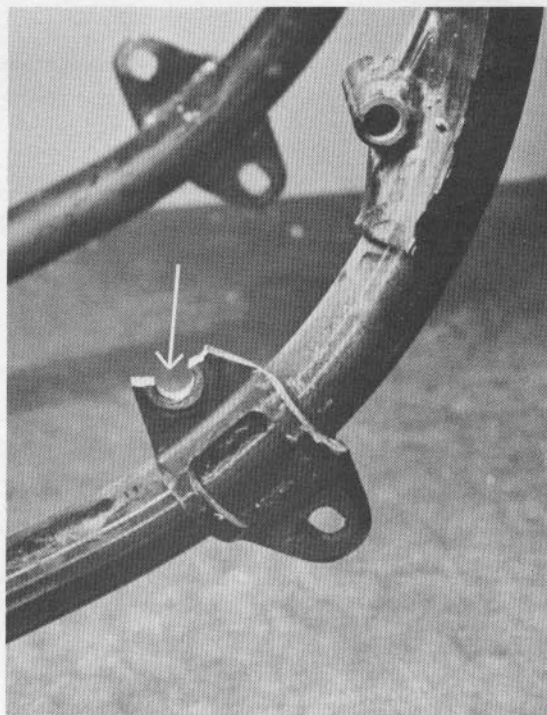
The H2 750cc engine can loosen in its frame mounting, causing rider discomfort and accelerated wear. In an extreme case, the frame lugs may fracture from engine vibration, aggravated by the loose mounts.

The frame lugs have 1.0-1.5mm clearance with the engine mounting bosses to allow easy removal/installation. These lugs are meant to be pulled in as the bolts are tightened. It has been found that the lugs take a "set", relieving tension on the mounting bolts.

Engine mount shims must be used to take up the clearance between the frame lugs and engine bosses at the two bottom mounts. The factory has installed these shims on all H2's after Frame No. H2F-09082.

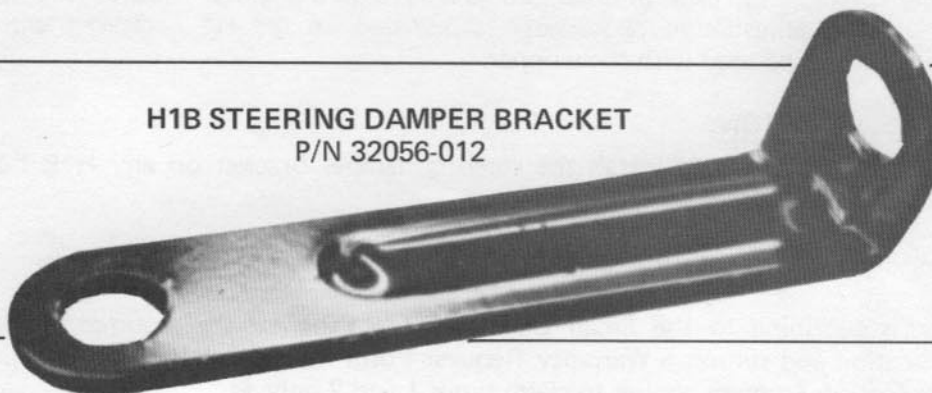
H1B STEERING DAMPER BRACKET
P/N 32056-012

With the damper in the #5 (hardest) position, the push-pull force can cause the damper rear frame stanchion to flex and bend.

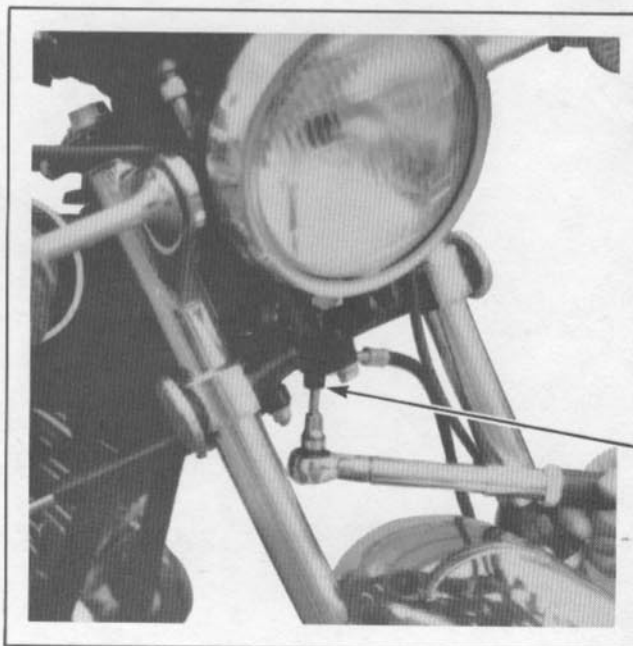
TIGHTEN TO
3.0 kg-m
(22 ft-lb)

On some H1E's between Frame Numbers H1F-025000 and H1F-030300 there may be a brake fluid leak around the allen bolt on the bottom of the steering stem.

- 1) **Tighten this allen bolt** on all affected H1E's to 3.0 kg-m (22 ft-lb).
- 2) If the bolt was loose, or if there are signs of brake fluid leakage, check brake lever operation and master cylinder brake fluid level.
- 3) If the brake lever is soft or if fluid level is low, bleed the brake system. Refer to H Series Shop Manual, Page 78.

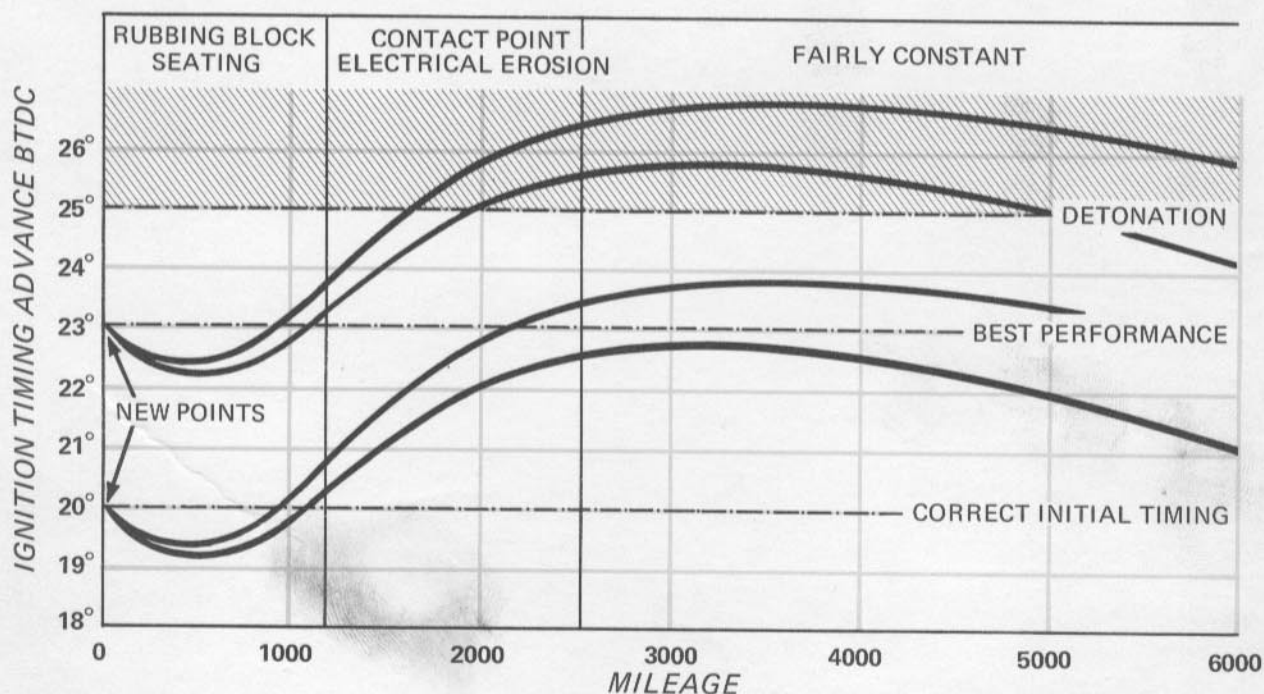
H1-B IGNITION TIMING CHANGE OVER FIRST 6000 MILES

Optimum ignition timing for the H1B is 23° (2.94mm) BTDC. The H1B has no ignition timing advance. The timing remains at a fixed point throughout the RPM range. However, as the graph below shows, if new points are initially set at 23° they will soon retard 1° because of rubbing block wearing-in, and then advance to more than 25° (from contact erosion) where detonation causes piston holing and severe engine damage. Since engine performance varies little from 19° to 25°, the factory recommends that new points be set at 20° BTDC (2.23mm). From this setting the timing will advance to 23° by itself in a matter of a few thousand miles. After 3000 miles, point wear levels off, so that when the points are adjusted after that time, they should be set at 23° until they are replaced.

NOTE: If plug fouling or sluggish performance is a serious problem on a new H1B, advancing the timing to 23° right away may solve the problem, but it will be necessary to check and adjust the timing frequently during the first few thousand miles to prevent engine damage due to overadvanced timing.
