©Kawasaki Motors Corp 1974 Printed in USA

PROBLEMS:

H1/H2 transmission problems have often included poor third gear engagement. This may be caused by two possible problems including the play of the fixed gears on the shafts and the lack of positive action in the third gear shift fork.

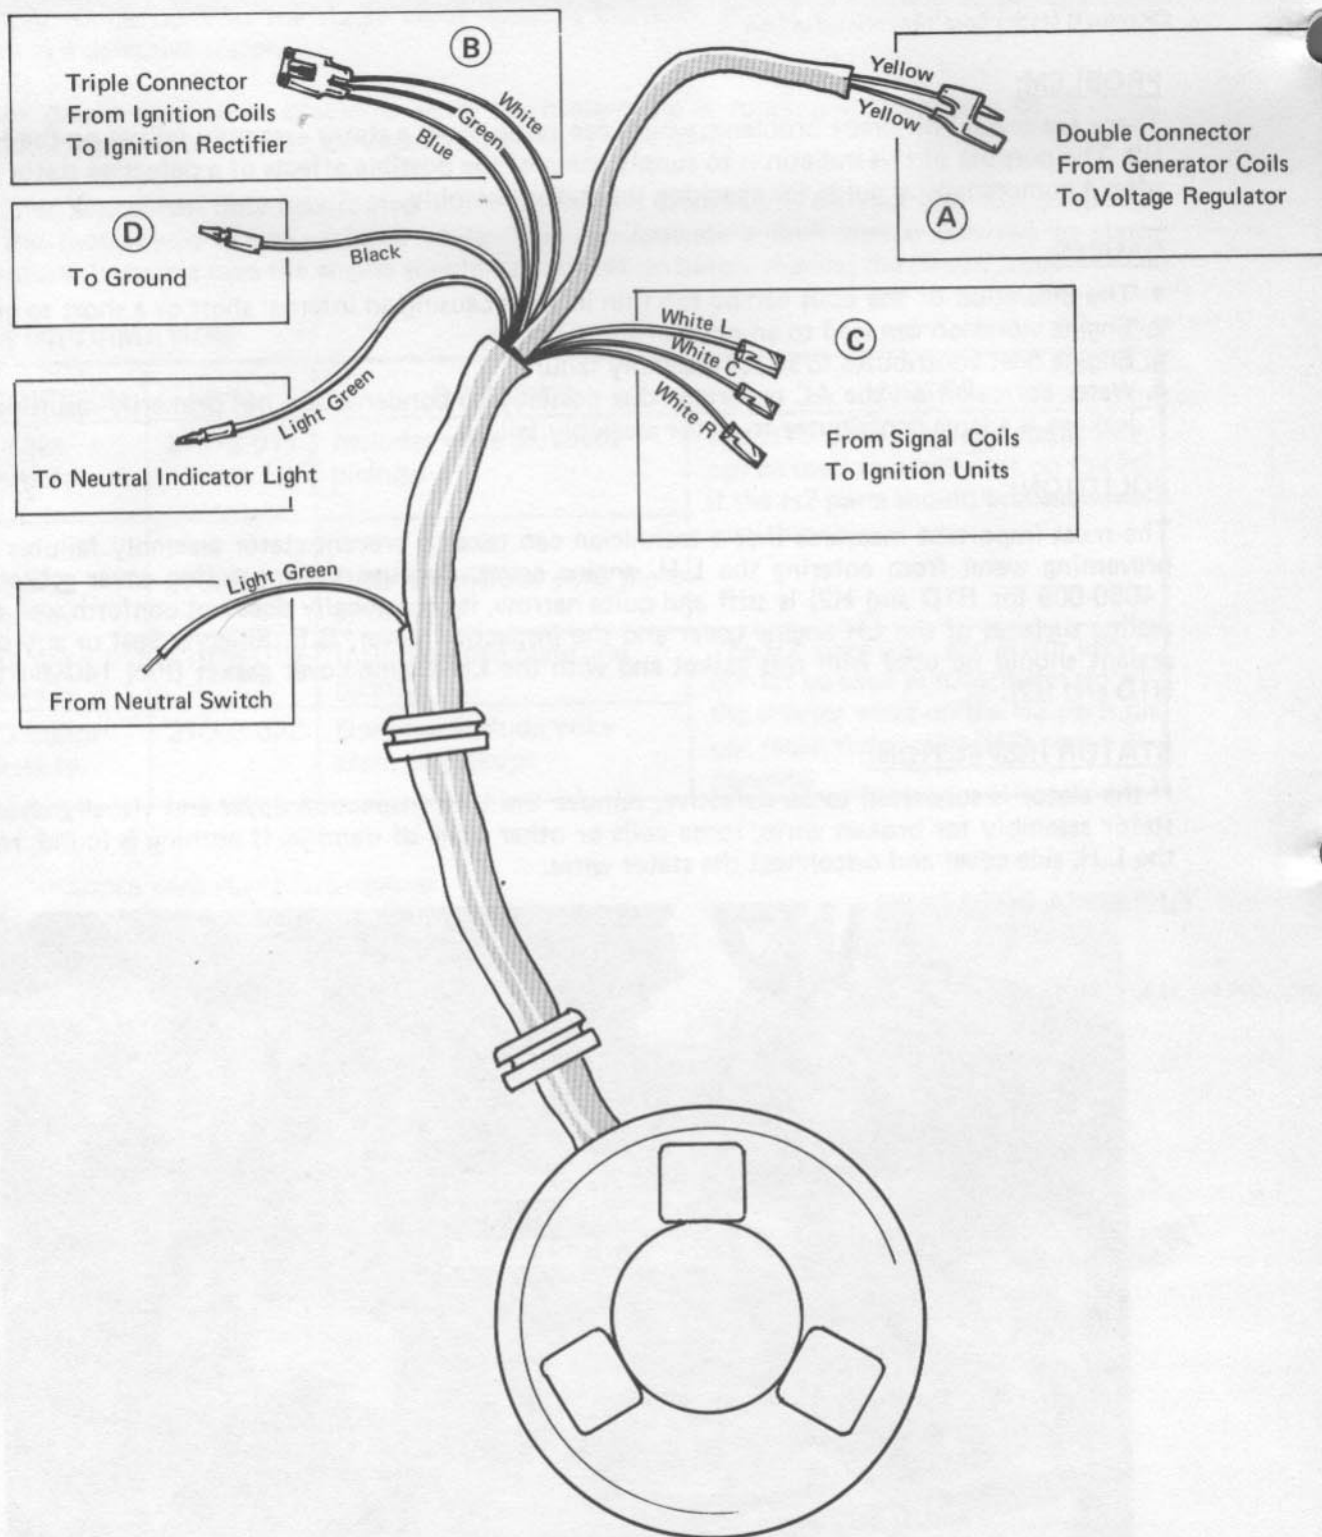
H2 Yoke Assy. and
Circuit Test Reference Code

There are several different problems which can result from a stator assembly failure on the H1D or H2. The purpose of this bulletin is to supply some of the possible effects of a defective stator and to offer a comprehensive guide for checking the stator assembly.

1. The insulation of the coils can be too thin in areas causing an internal short or a short to ground.
2. Engine vibration can lead to an open or short circuit.
3. Engine heat contributes to stator assembly failure.
4. Water corrosion on the AC generator due partially to condensation but primarily resulting from leakage is a large contributor to stator assembly failure.

If the stator is suspected to be defective, remove the L.H. inspection cover and visually check the stator assembly for broken wires, loose coils or other signs of damage. If nothing is found, remove the L.H. side cover and disconnect the stator wires.

Then by using a Kawasaki ohm meter (P/N 56019-037) follow the circuit tests below. **NOTE:** It is advisable to make these checks with the stator installed on the engine, because some problems such as the stator coils touching the engine crankcase may otherwise go undetected.

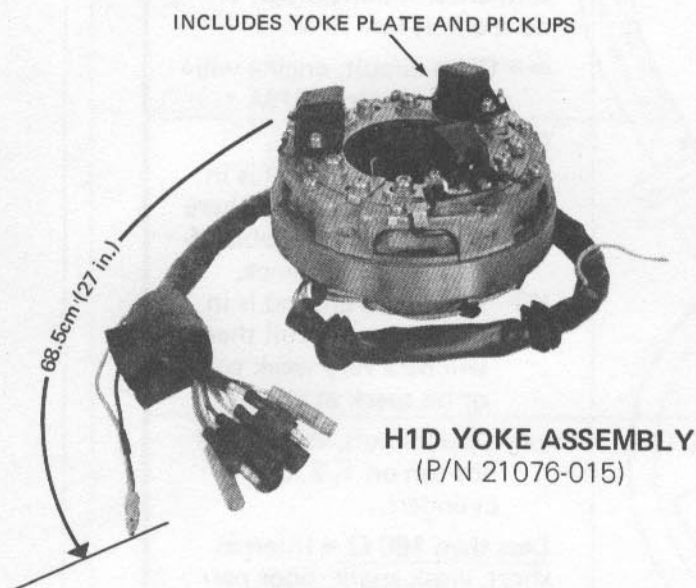
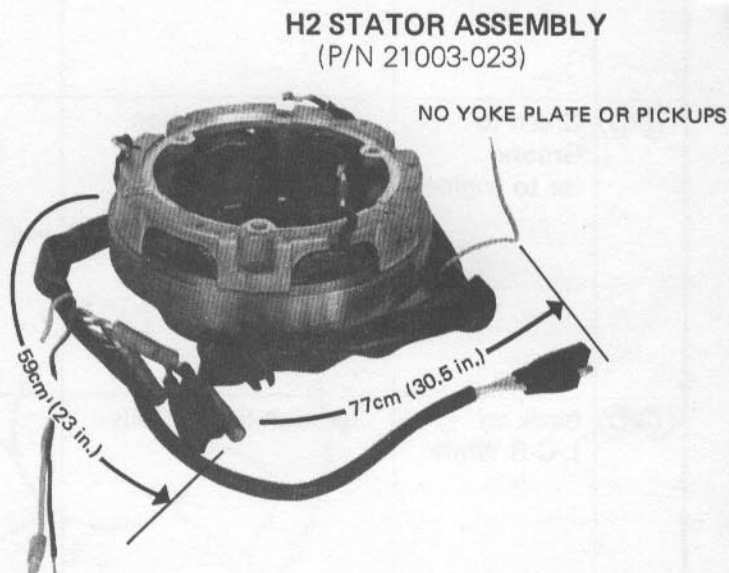
NOTE: The above photos illustrate the following:

1. The difference between a yoke assembly and a stator assembly.
2. The difference between an H1D and an H2 wiring harness. All the wires of the H1D harness are the same length. The wires of the H2 are two lengths — two wires longer than the H1D harness and the rest shorter.■

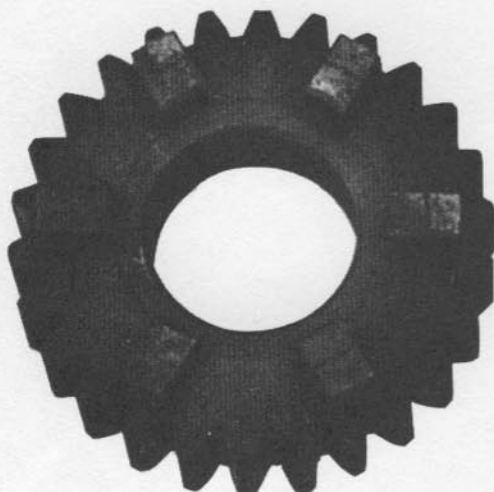
**OLD**

In the transmissions of H1 models there is a possibility for unusually fast wear on the inside of top gear on the drive shaft. As the gear wears, it begins to wobble on the shaft, eventually causing serious trouble in the transmission.

Top Gear
(No Bushing)
P/N 13136-022

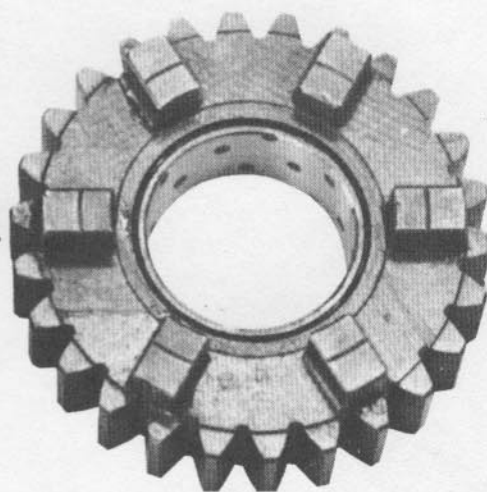
**NEW**

Top Gear
Bronze Bushing
P/N 13136-041

To eliminate this possibility, top gear on the drive shaft has been changed. The new gear is made with a pressed in bronze bushing for extended life. This change has been applied to all H1's in production from frame number KAF-57161, and to all H2's from beginning of production.

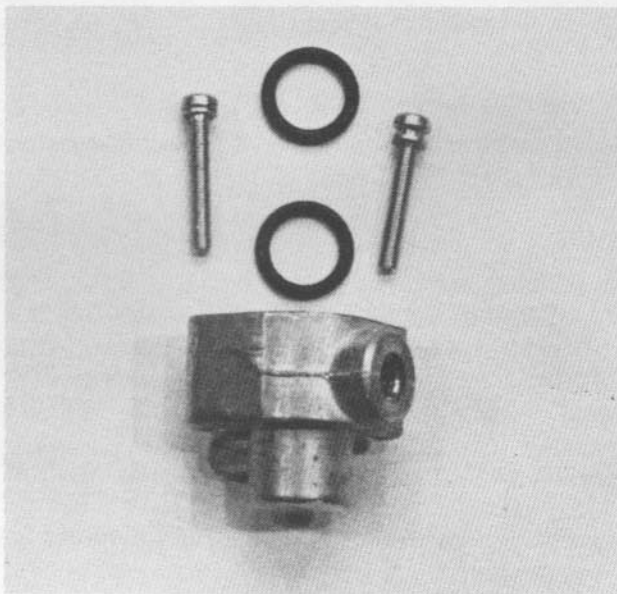
P/N 99990-016

This problem has been traced to faulty O-ring seating in the oil pump end cover. After installation, the two O-rings inside the cover shrink approximately .1 to .2mm in diameter. This shrinkage allows oil to seep around the seals and into the end cover chamber. From this point, the excess oil is pumped to the right cylinder which is serviced by the end cover orifice, resulting in smoking and premature sparkplug failure.

Three Cylinder Oil Pump
Conversion Kit

Whenever an oil pump is disassembled for *any* reason, the O-rings must be replaced. The end cover O-rings are P/N 16090-002.

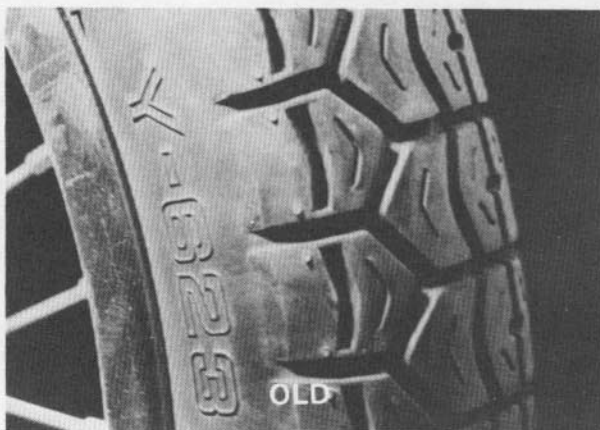
YOKOHAMA 3.25-19 Y-623
P/N 41021-018

Based on the finding of an extensive testing program, it is suggested that the original 3.25-19 Yokohama Y-623 front tire P/N 41021-018 be replaced with a new-type Dunlop H3.25-19 F6 tire, P/N 41021-029. Thousands of test miles on a number of different H2's, under widely varying road and speed conditions, have shown that this new tire definitely improves the H2's high-speed handling characteristics.

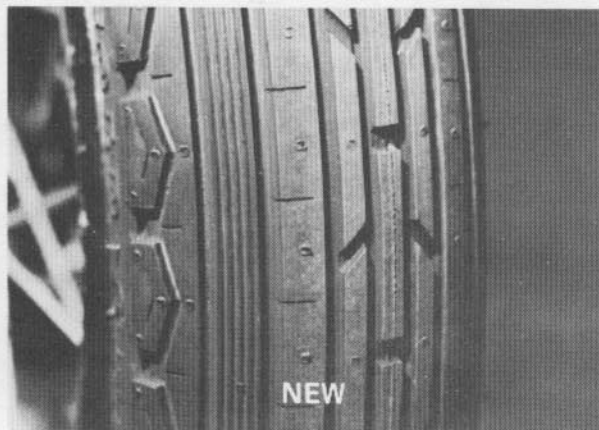
DUNLOP H3.25-19 F-6B
P/N 41021-029

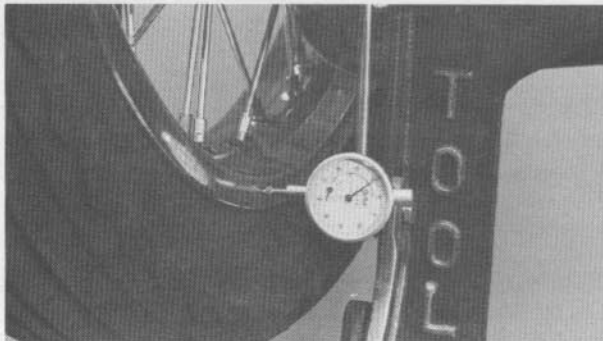
LATERAL RUNOUT

Standard 1mm (.04")
Service Limit 3mm (.12")

- A. **WHEEL TRUING:** After mounting the new tire, place the wheel in a wheel truing stand, and, making sure that all spokes are tight, adjust the lateral and radial runout. Standard lateral runout is 1mm (.04") with a service limit of 3mm (.12"). Standard radial runout is also 1mm, but the service limit is 2mm (.08").

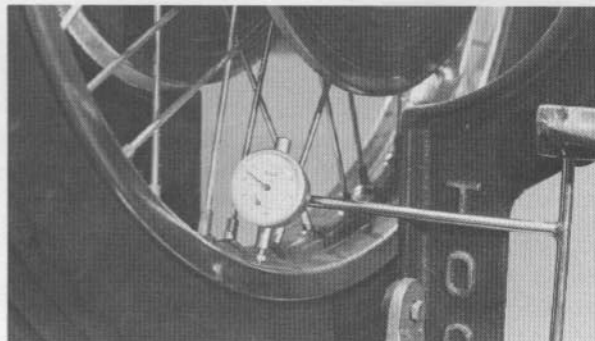
RADIAL RUNOUT

Standard 1mm (.04")
Service Limit 2mm (.08")

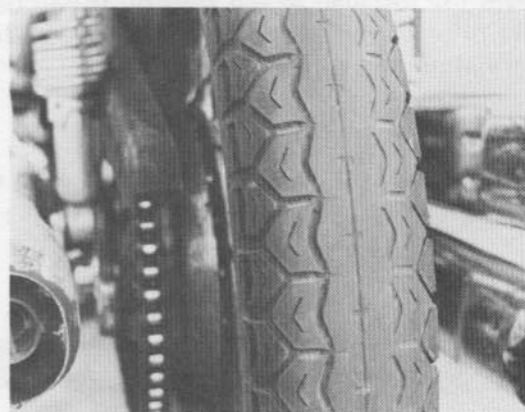
EXCESSIVE WEAR

- D. **REAR TIRE:** In some cases, an excessively worn back tire will contribute to high-speed wobble. Any such tire should be replaced if instability is to be cured completely.

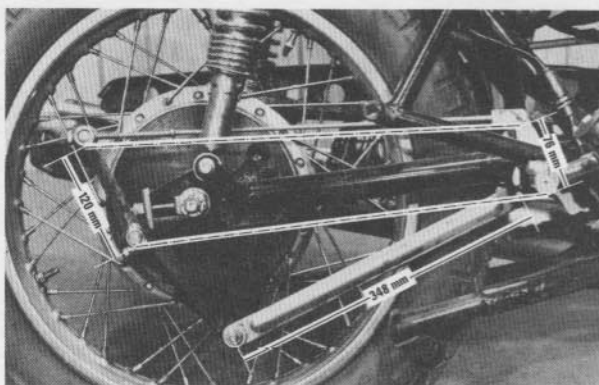
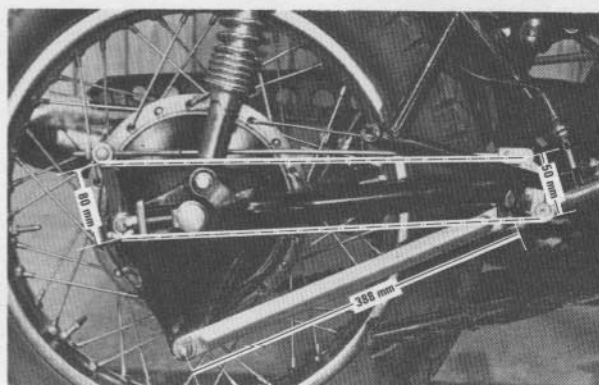
OLD

The factory has redesigned the rear brake linkage parts to give a more positive brake feel. The torque link has been lengthened, the brake rod now has a 5° accommodation bend in it, and the brake cam lever and the brake pedal shaft lever have both been shortened. These changes greatly improve braking smoothness without affecting overall brake leverage. The new parts have been incorporated on H2's after frame No. H2F-05214.

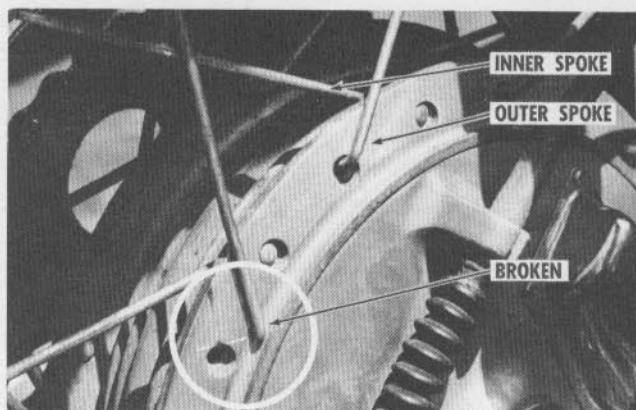
EARLY H1 STRAIGHT-TYPE SPOKES

On all H1's after frame number KAF-47245, the rear wheel spokes are changed for more strength. The gauge of the spoke is increased from #9 to #8 at the hub end.

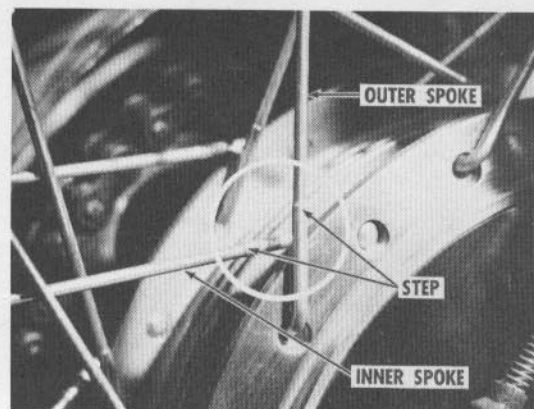
LATE H1 STEPPED-TYPE SPOKES

NOTE: Spoke breakage is accelerated by corrosion and looseness. Make sure the end of the battery vent hose is pointed away from the wheel. In coastal regions and during wintertime in northern regions, the motorcycle is exposed to salt water corrosion, which can weaken the spokes. Repeated flexing and stretching will bring on early spoke failure; this can be minimized by checking and tightening the spokes at regular intervals (every month or each 2000 miles).

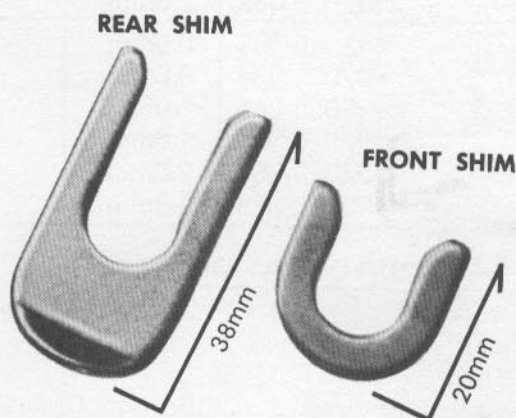
The H2 750cc engine can loosen in its frame mounting, causing rider discomfort and accelerated wear. In an extreme case, the frame lugs may fracture from engine vibration, aggravated by the loose mounts.

The frame lugs have 1.0-1.5mm clearance with the engine mounting bosses to allow easy removal/installation. These lugs are meant to be pulled in as the bolts are tightened. It has been found that the lugs take a "set", relieving tension on the mounting bolts.

For all units before frame number H2-09082, the shims *must* be installed.

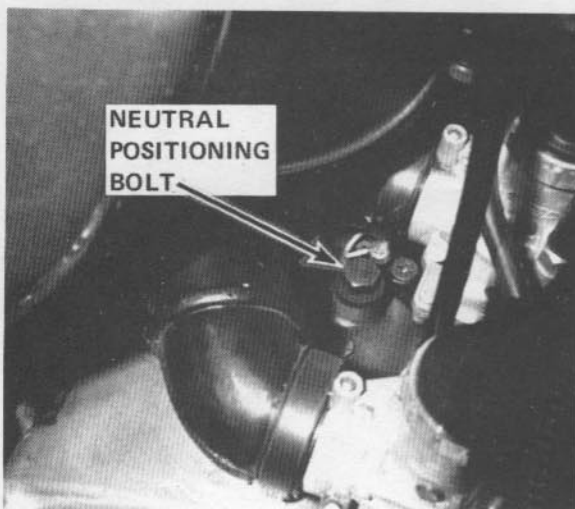
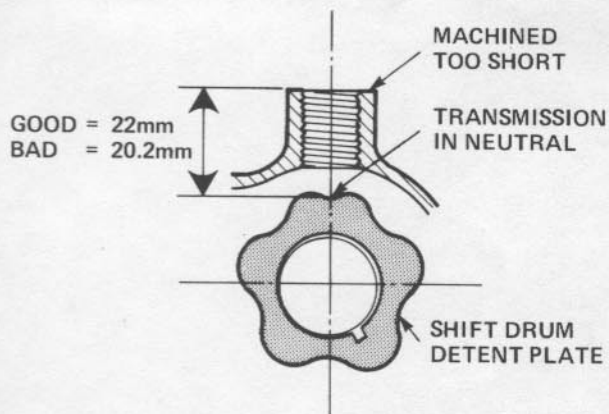
PROBLEM: Neutral Positioning Bolt Boss Too Short

The 1976 KH500 has a neutral positioning bolt on the upper crankcase. On some early KH500's, the positioning bolt boss was machined too short. Installation of the positioning bolt and pin in a short boss may interfere with normal gear changing.

FACTORY ACTION: Installed Extra Gasket and Washer

All affected units have an added gasket and washer under the neutral positioning bolt.

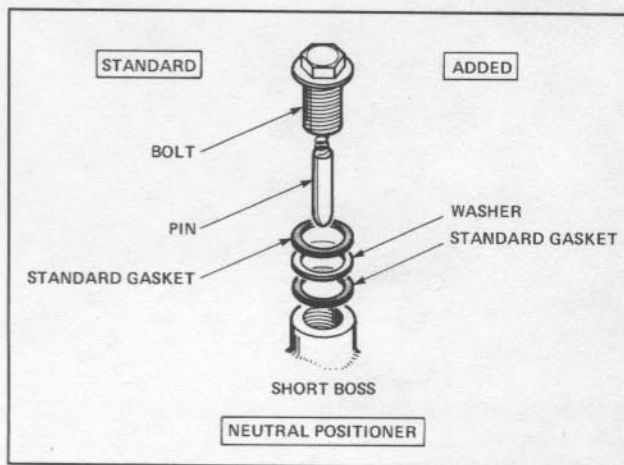
Check for the added parts any time the neutral positioner is removed, or whenever a customer complains of shifting problems on an affected unit.

DEALER ACTION: When Servicing Affected Units, Reinstall Added Parts

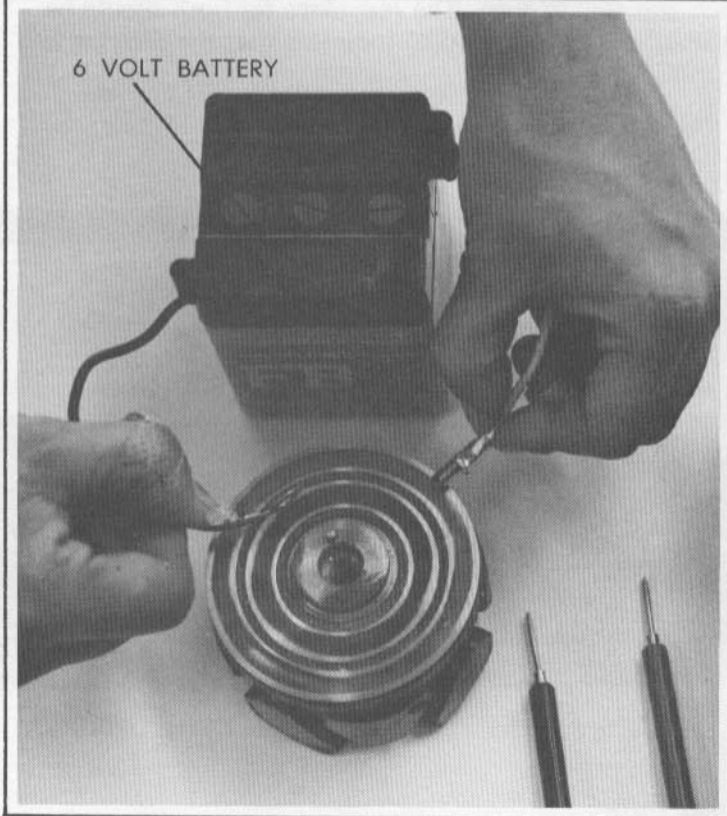
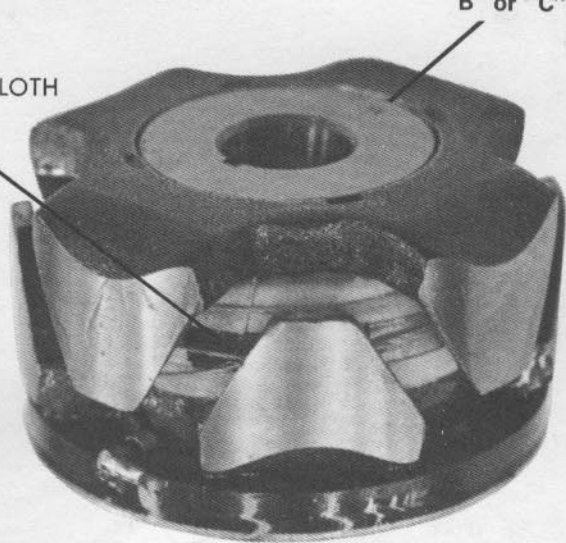
SQUARE HOLE IN CLOTH

There have been two changes in the rotor (part no. unchanged) to counter-measure this tendency toward high rpm failure. These rotors may be identified by square holes in the insulating cloth on the windings. The "B" type rotor is used in production from engine number KAE-43491 to KAE-69531. The latest modification, marked "C", changes the rubber based resin to plastic based. This rotor is used on engines KAE-69532 and up.

With any of these types of failure, the rotor must be replaced.

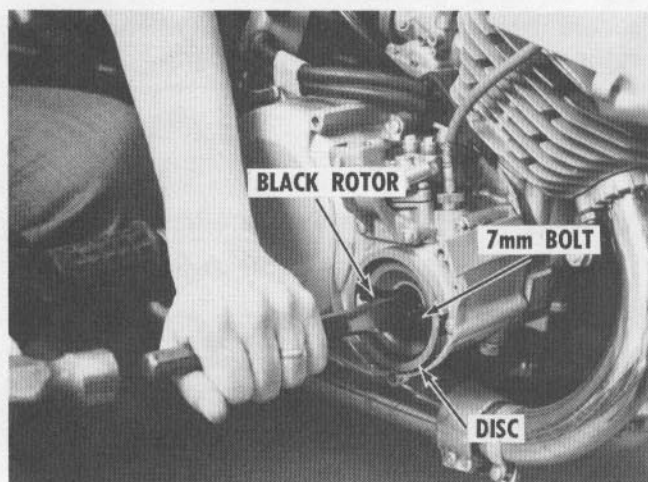
REMOVING BLACK ROTOR:

- A. **ALL H1's BEFORE KAE-08801:** These units have the early distributor shaft and black rotor which is secured by a bolt and lock plate. The heavy duty (H.D.) rotor made of brown plastic should be used for repair. This rotor is held on the distributor shaft by a spring clip and pressure from the center brush in the distributor cap. Installation of the H.D. brown rotor is shown below.

Break off the rotor arm on the same side as the bolt. Crack and remove the insulator disc. Take out the bolt with a 7mm wrench.

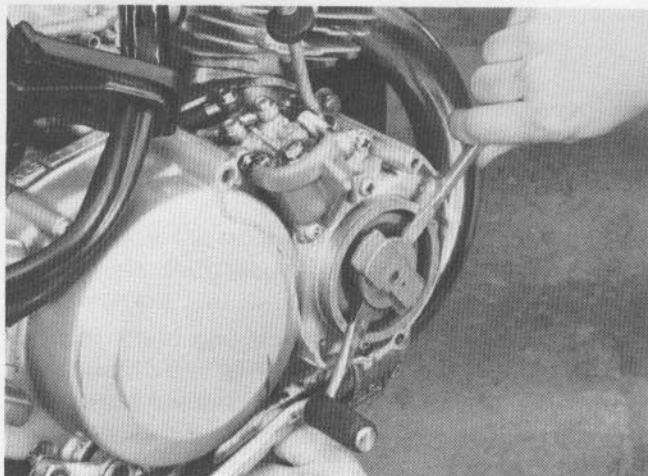
TO REMOVE:

B. **ALL H1's AFTER KAE-08800.** These later units incorporate a new green rotor and quick-detach distributor shaft. The shaft is fitted with a snap-ring that retains an internal groove in the rotor. The hole in the insulating disc is increased from 28mm I.D. to 31mm I.D. because the green rotor has a larger diameter sleeve. Removal and installation of the new rotor is shown below.

Turn the rotor so it points as shown. Pry on opposite sides of the rotor with two large screwdrivers and it will pop off.

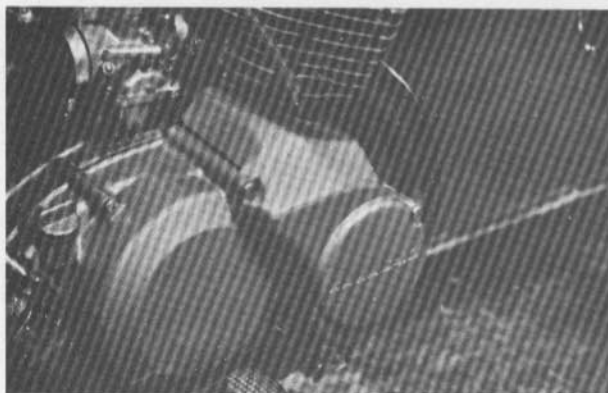
EARLY H.T. WIRING

The spark plugs generally are not the cause of the problem. We have found the high tension wiring leaks electricity to adjoining metal engine parts under high voltage loads. New spark plugs require less voltage to fire because the electrodes have sharp edges. As the plugs are used, these sharp edges are rounded off by high energy discharge and erosion from heat and chemical action in the combustion chamber. Consequently, they require an increasing amount of voltage to fire as mileage accumulates. Worn spark plugs, over-rich oil pump settings, or incorrect fuel mixtures demand more voltage from the ignition system to fire the spark plugs. These conditions "back up" the voltage in the secondary wiring until it jumps through the H.T. cord insulation to an inviting engine ground rather than fire the plugs.

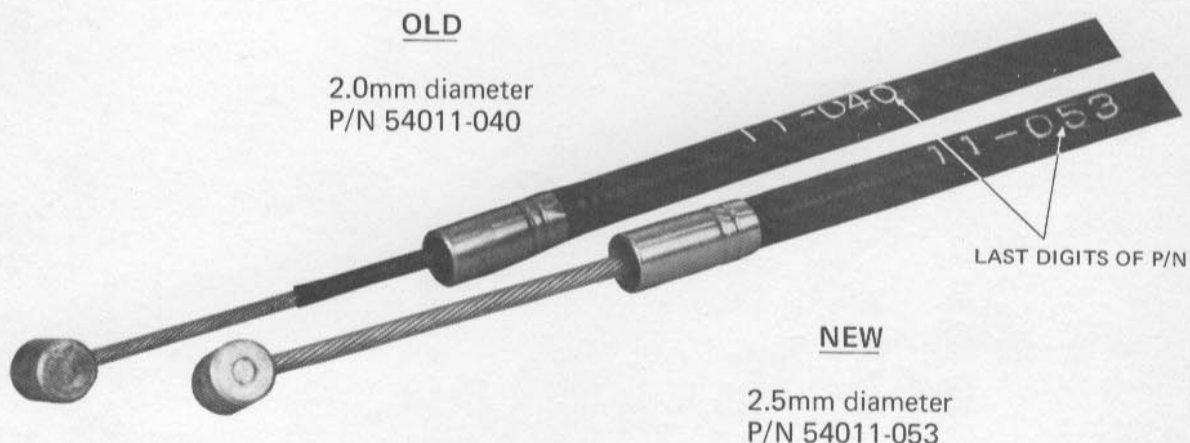
Clutch cable breakage has been a regular problem on the S1 and S2. This is primarily the result of excessive wear at the hand lever. The cable flexes at the lever and the cable strands break at the lead nipple.

To correct this a new 2.5mm diameter cable has been used on all S1 and S2 motorcycles after engine number S1E-08257 and S2E-38301 and up. This new cable (P/N 54011-053) is 0.5mm thicker in diameter and has a teflon-type coating on the inside of the outer cable housing to reduce frictional wear.

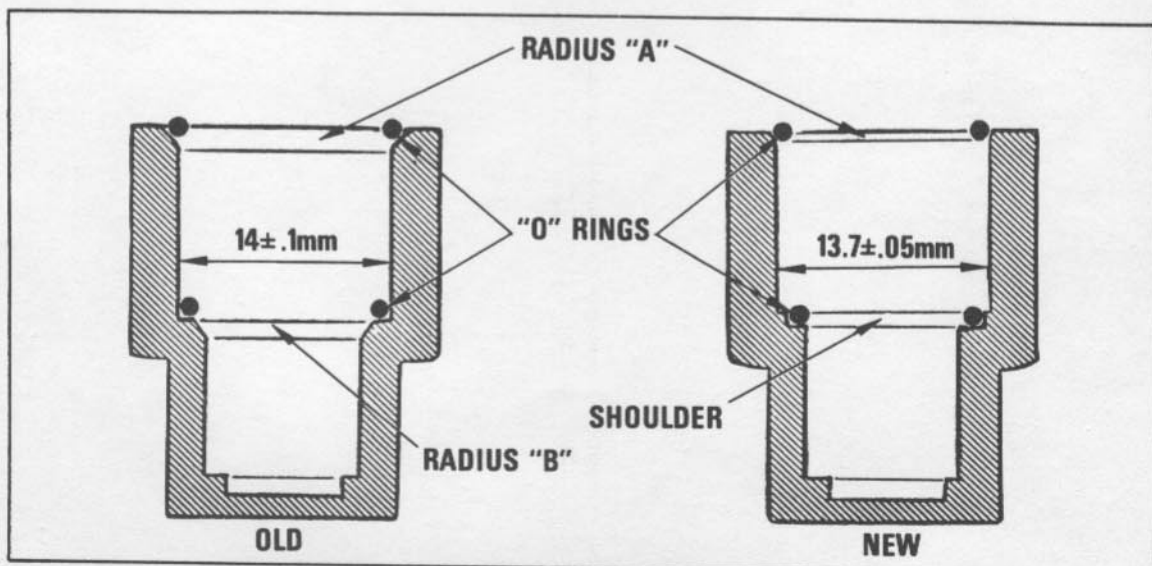
This problem has been traced to faulty O-ring seating in the oil pump end cover. After installation, the two O-rings inside the cover shrink approximately .1 to .2mm in diameter. This shrinkage allows oil to seep around the seals and into the end cover chamber. From this point, the excess oil is pumped to the right cylinder, which is serviced by the end cover orifice, resulting in smoking and premature spark plug failure.

To remedy this problem, the oil pump end cover has been redesigned to stop oil seepage. The illustration below points out the differences between the old and new covers.

- A. Radius "A" has been decreased in depth to give the O-rings less "squish" space, making a tighter seal.
- B. Radius "B" has been eliminated altogether to improve the seal at that point.
- C. The internal diameter of the chamber has been decreased from $14 \pm .1\text{mm}$ to $13.7 \pm .05\text{mm}$ to compensate for O-ring shrinkage.
- D. A slight shoulder has been added to the base of the new chamber to further compress the O-ring.

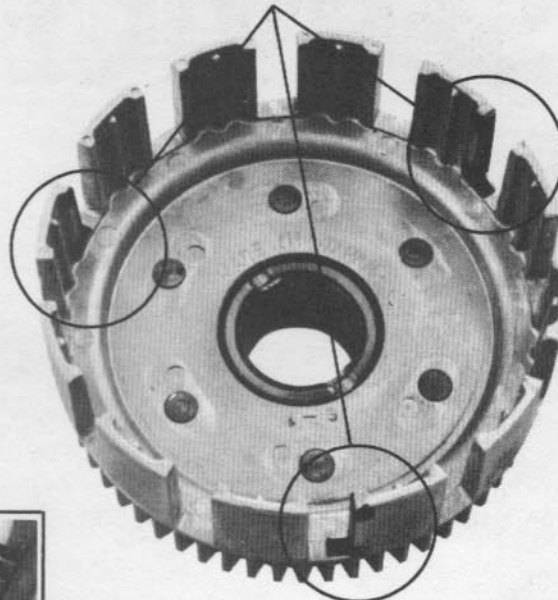
SHIMS ON "COAST" SIDE ONLY

The rattling noise is evidence of excessive clearance between the clutch housing drive fingers and the driven tabs on the friction plates. Slight variations in the clutch housing RPM resulting from engine firing impulses cause the housing to speed up and slow down slightly, and the tabs of the friction plates, held together by the clutch spring, are struck on one side (load) and then the other side (coast) by the housing fingers. Standard clearance between the fingers and the tabs is 0.002-0.022" (0.05-0.555 mm). As the clearance exceeds 0.010" (0.25mm), however, clutch rattle becomes more evident.

To install the shims, drain the oil and take off the right engine cover. Remove the pressure plate bolts and springs, and then take off the pressure plate and pull the clutch plate "pack". Install the three shims as shown here, at 120° intervals, or 4 fingers apart. **IMPORTANT:** The shims must be installed on the "coast" side of the clutch housing finger. **NOTE:** Make sure the three shims are all the same thickness.

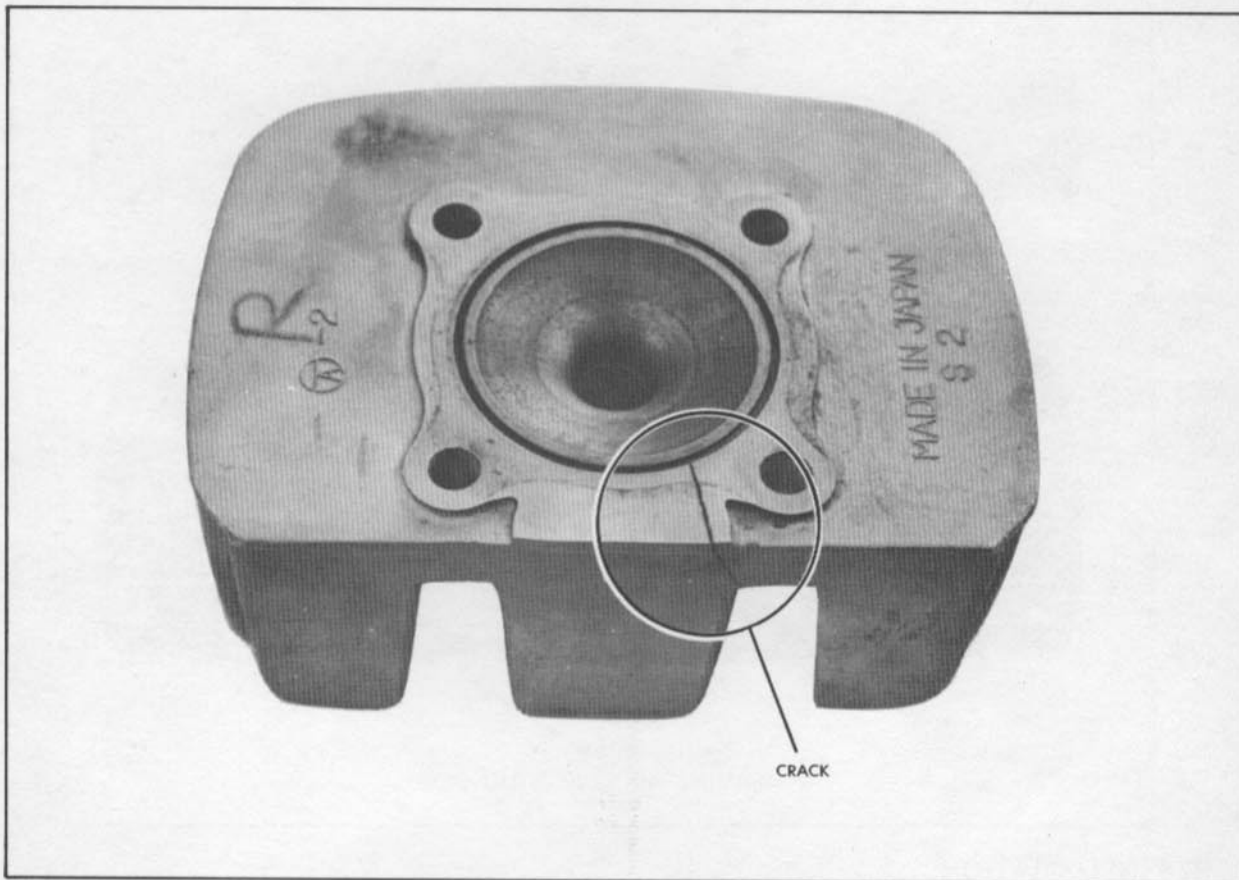
On some early S2 machines, there is a slight possibility of the cylinder heads cracking as shown below. Our experience indicates that the fault may occur under conditions of hard usage, such as extended full throttle operation for long periods of time.

With a cracked cylinder head, there is a slight power loss in the high RPM range in 4th and 5th gear. On some units the engine may detonate because fuel/air mixtures are upset from leakage. Generally, a cracked head will not be visually noticeable unless the head is removed from the engine.

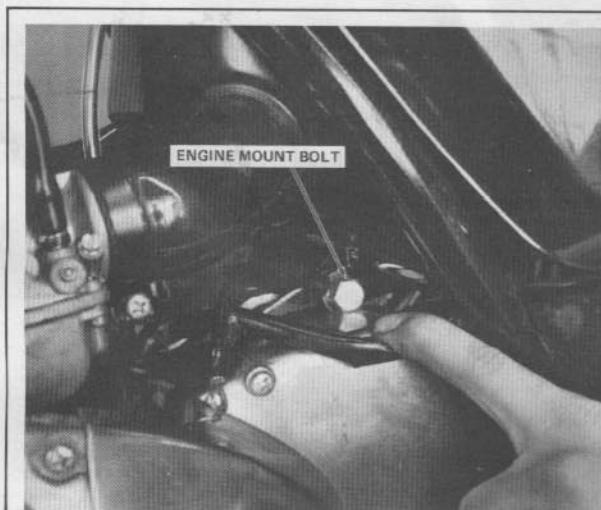
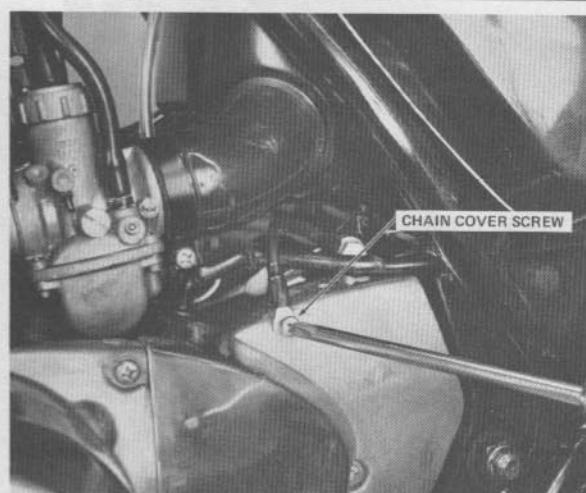
This problem has been cured in production after frame number S3F-005187 by the addition of a ground wire between the frame and the engine chain cover. A heavy gauge lead is used to assure the least possible resistance between the engine and frame.

For proper ignition performance under all conditions this ground wire (P/N 26011-084) must be installed on all S3 motorcycles before frame number S3F-005187.
