**BULLETIN SER 74 H-28**

## IMPORTANT NOTICE

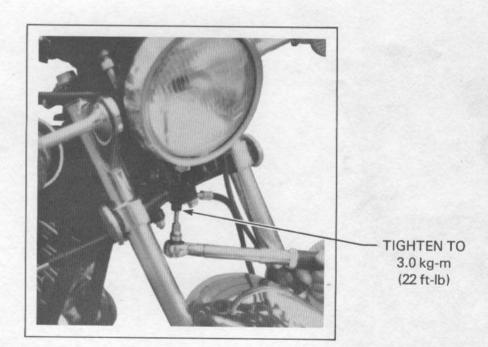
On some H1E's between Frame Numbers H1F-025000 and H1F-030300 there may be a brake fluid leak around the allen bolt on the bottom of the steering stem.

- 1) Tighten this allen bolt on all affected H1E's to 3.0 kg-m (22 ft-lb).
- 2) If the bolt was loose, or if there are signs of brake fluid leakage, check brake lever operation and master cylinder brake fluid level.
- If the brake lever is soft or if fluid level is low, bleed the brake system. Refer to H Series Shop Manual, Page 78.
